Challenge

Fiber flow drum

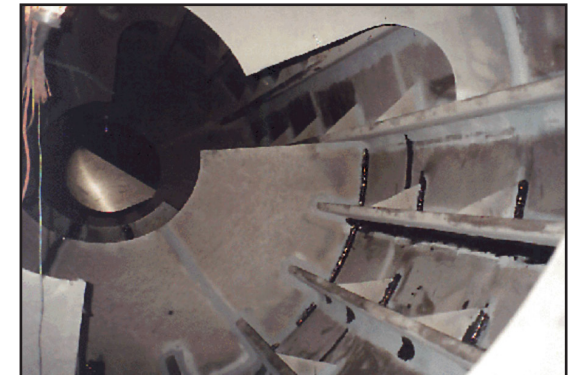
ARC 858 and ARC 855 being applied to weld zones

1. Apply **ARC 858** to the weld seams to build up irregularities, pits, and damage. Curve out angles and corners too prevent pulp collecting on longitudinal vanes
2. Apply **ARC 858** as a topcoat to provide corrosion protection over a larger area and to reduce surface friction
