## Challenge

This plant's FGD system was experiencing a loss of efficiency in their absorber recirculation pumps. After only 18 months of operation, the motor-driven current values increased from 11.1 Amps to 12.1 Amps - an increase of over 9%.

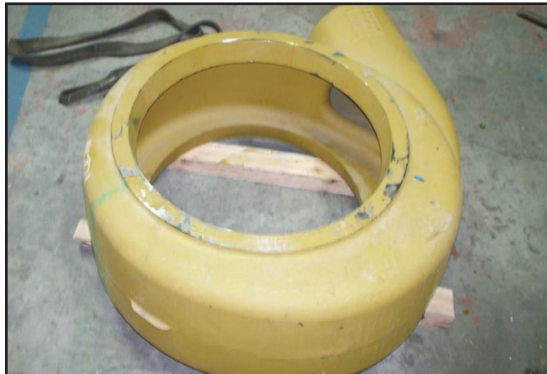
New pump casing before application of ARC

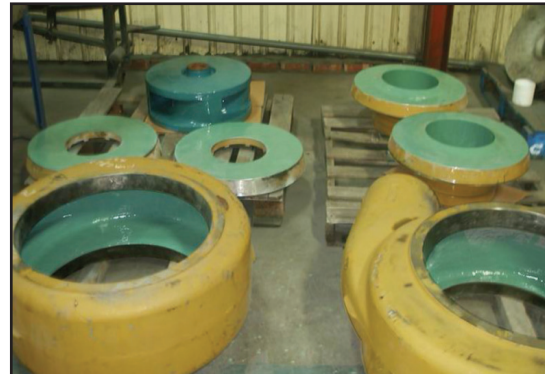
Two new pumps protected with ARC

1. Application of 6mm **ARC MX1** on the suction wear plates, and 3-4 mm of **ARC BX2\*** to protect the volute body
2. Topcoat with **ARC S2** to provide a smooth flow efficient surface

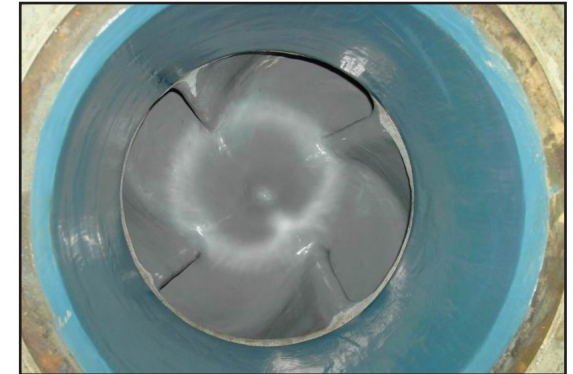
Completed application
