## Challenge

Mine production impacted by insufficient pump performance to meet required 300M<sup>3</sup>/hour flow.

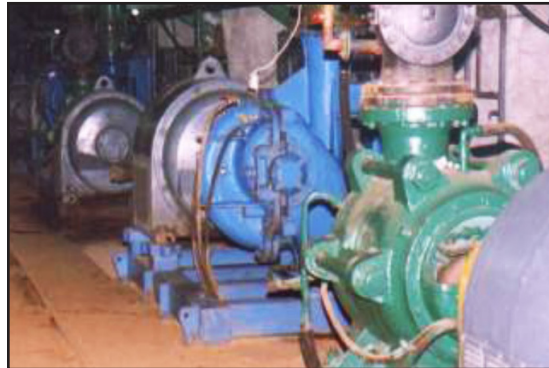
After 20,000 hours operation in acidic mine water with entrained solids degraded pump internals and critical tolerances.

Bank of dewatering pumps

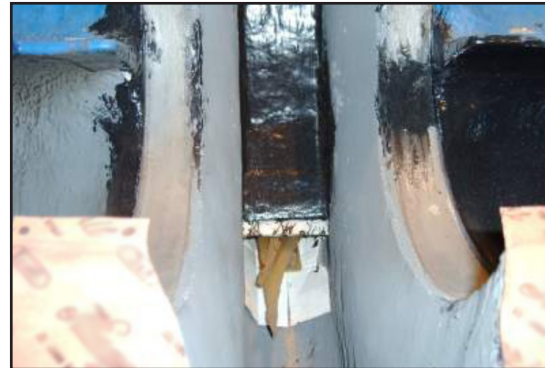
Pumps rebuilt with ARC 858 and ARC MX2. Top coated with ARC 855

Surfaces grit blasted to Sa 2.5 with 3 mil (75 µm) angular profile.

1. Apply **ARC 858**, to rebuild pump back to tolerances where abrasion and erosion had damaged casing and impeller
2. Apply **ARC MX2** in high wear regions to address abrasive suspended solids
3. Apply final topcoat of **ARC 855** for additional corrosion protection and to improve flow efficiency

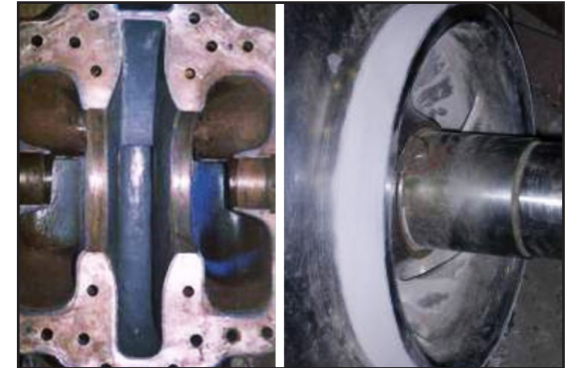
Coated sections of pump
