## Challenge

Provide 6 year's of service life to the main seawater cooling pump.

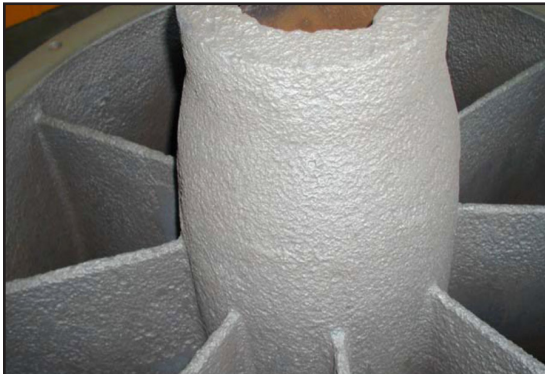
Severe corrosion at bottom part of the pump, bell housing, and diffuser vanes.

*Pump diffuser after removal of old coal tar epoxy coating*

- Remove remainder of coal tar epoxy coating
- Grit blast to Sa 2.5 with 3 mil (75 µm) angular profile

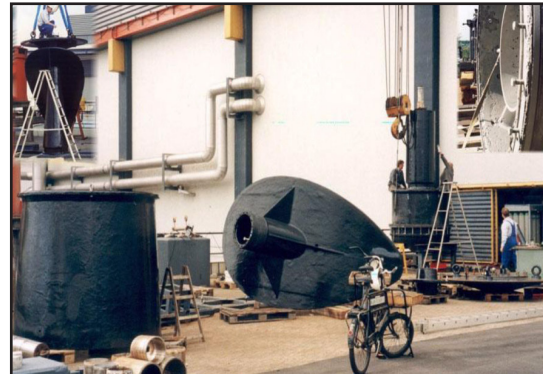
*Completed application of ARC 858 and ARC 855 to all the wet end pump components*

1. Repaired and rebuilt severe corrosion pitting using **ARC 858**
2. Three coats of **ARC 855** with DFT of 14 mils (350 µm) per coat

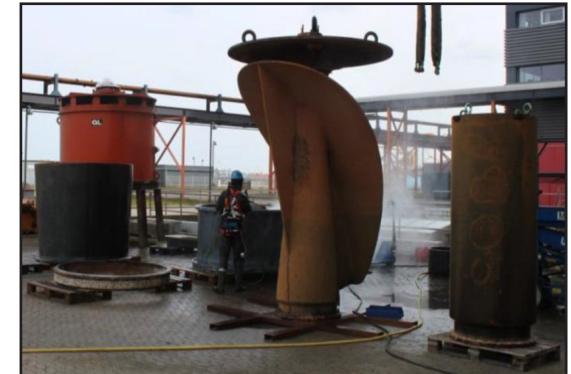
*Inspection after 18 years service revealed the ARC 855 coating still to be in excellent condition*
