## Challenge

Waterbox end covers and divider plates were corroding and leaking requiring unscheduled unit shut-downs to weld plates.

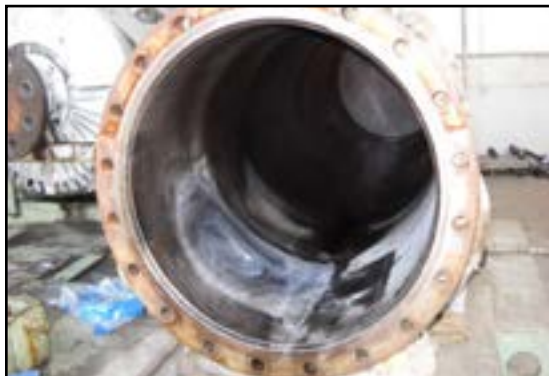
Premature failure of the coal tar epoxy coating led to extensive galvanic corrosion and pitting.

Damaged heat exchanger

- Mechanically remove old coating
- Decontaminate substrate
- Grit blast to Sa 2.5 with 3 mil (>75 µm) angular profile

1. Apply [ARC 858](#) to replace lost metal
2. Apply 2 coats of [ARC 855](#) and [ARC S2](#)

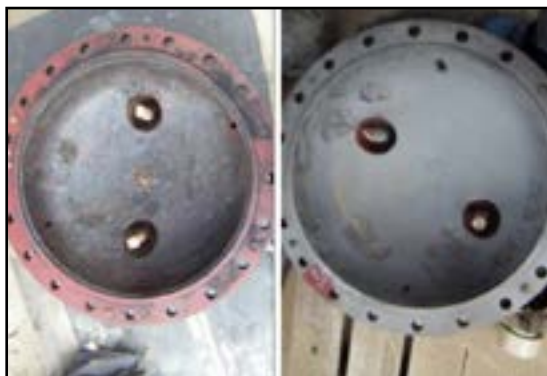
Removal of coal tar epoxy costing

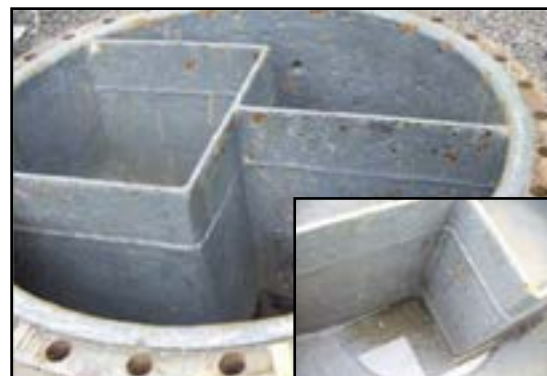
- 6+ years in service with coating in excellent condition
- Increased efficiency of heat exchanger
- ARC solution ordered for additional heat exchangers

After coating with ARC 855 and ARC S2
