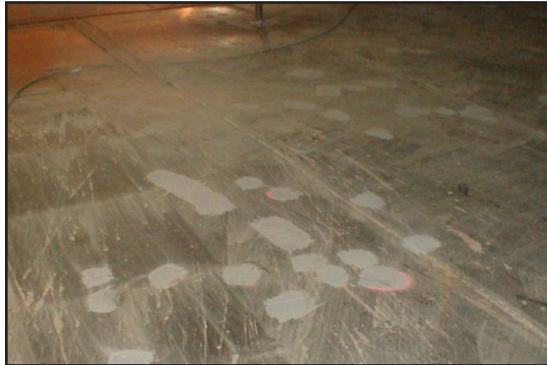
Previously applied coating had failed after 2 years, resulting in severe pitting and weld zone corrosion. Client was forced to replace 10% of floor plate at cost of €175K. 40% of floor experienced pitting corrosion up to 30% of plate thickness.

Prior failed lining and corrosive effects of seawater.

Severe pitting corrosion found under the existing coating repaired with ARC 858

1. Corroded and pitted areas were brought back to 100% of original thickness with **ARC 858**
2. Use **ARC S1** to stripe coat weld seams, striker plates, and transition points
3. Apply 2 coats of **ARC S1** via heated plural component spray equipment to a total DFT of 20 mils (500 µm)

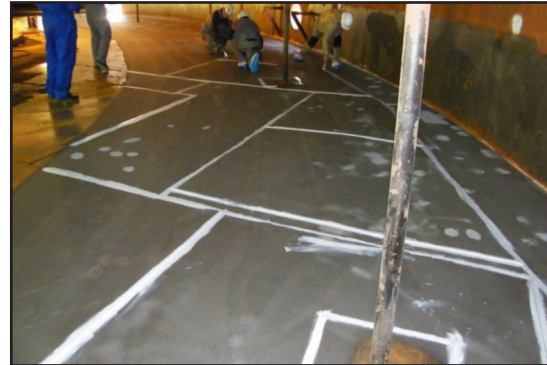
Application of the stripe coat to all weld seams

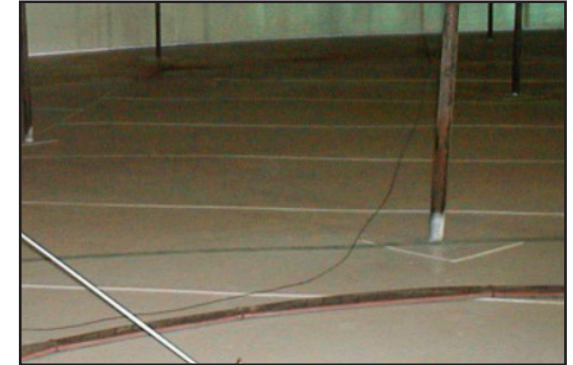
Final inspection of the ARC lining to ensure a continuous pinhole free protective lining
