## Challenge

Area of rubber lining failure encroach into press section and damage paper mat as it passes over damaged section. Increased scrap costs are incurred and result in 1 week downtime for rubber repair.

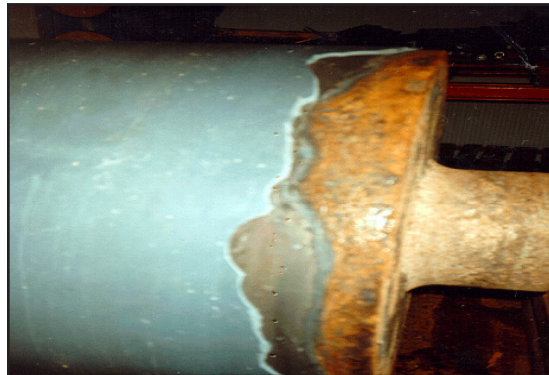
Process fluid leaks into end caps causing underfilm corrosion at rubber lining interface leading to delamination.

Delamination cover plate transition

- Undercut rubber to tightly adhered area
- Create beveled cut into adhered rubber
- Mechanically prepare exposed metal to Sa 2.5 with 3 mil (75 µm) profile

1. Install oversized platen on outer edge of roll coating internal face with release agent
2. Apply bead of **ARC 858** between platen and existing rubber to fill area of removed rubber
3. When cured, remove platen, grind **ARC 858** to RMS finish of 12

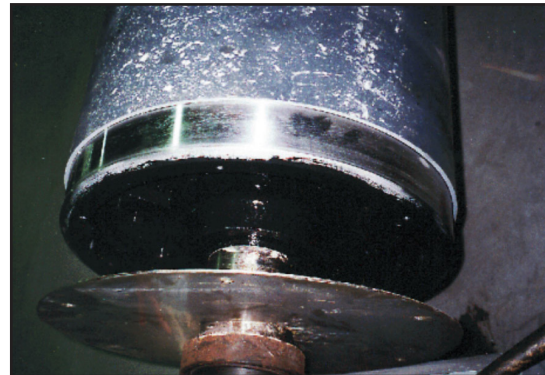
Surface prepared for ARC 858

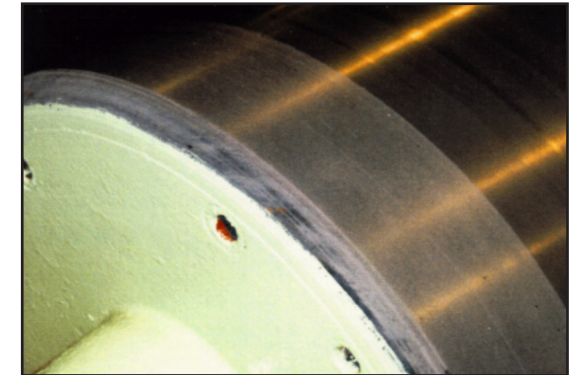
Rebuilt and ground for production

- Repair time reduced from 7 days to half day for ARC repair
- >48 months of operation without coating failure
