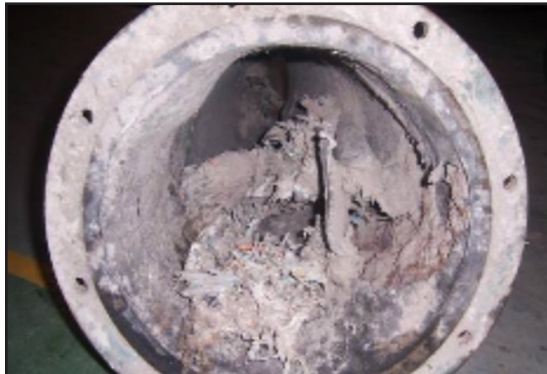
Delamination of rubber lined exit cones led to plugging of system and reduced maintenance cycle to 3 months.

Rubber liners delaminate at upper seam due to abrasive flow.

Rubber liner at 3 months

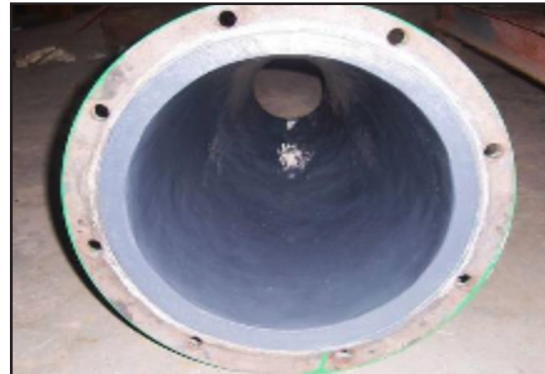
Repaired exit cone

- Remove existing rubber liner then steam clean at 100 bar (1400 psi)
- Grit blast to Sa 2.5 with 3 mil (75 µm) angular profile

1. Rebuild pitted areas with **ARC 858**
2. Mold liner to ¾ inch (18 mm) with **ARC MX1** to accommodate previous rubber lining thickness
3. Apply 1 coat **ARC 855** ~DFT: 30 mils (0,75 mm)

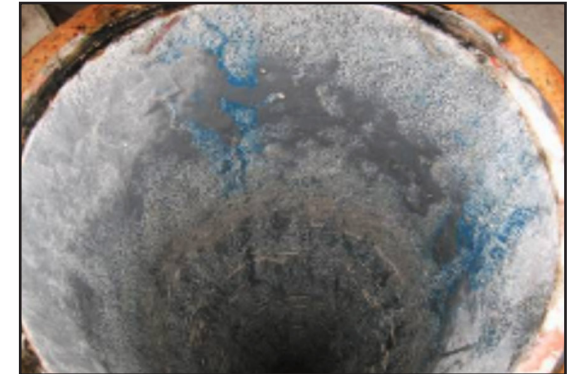
12 month inspection working perfectly
