Challenge

Damaged cooling tower fan blades. Required an application of an erosion resistant, low co-efficient of friction coating to reduce dust buildup and prevent moisture ingress.

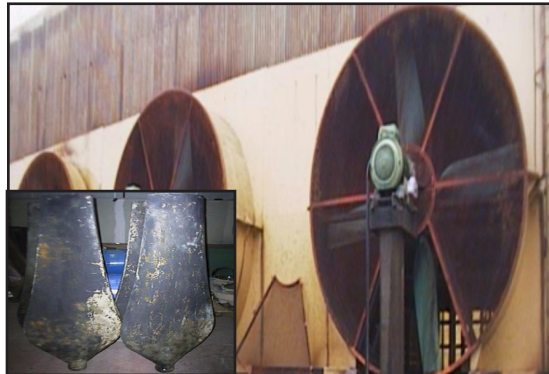
Cracking of the fan blades resulted in moisture penetration of the structural integrity, leading to imbalance.

Damaged fan blades
