Challenge

Issue

Failure of previous coating system resulted in advanced corrosion to internals of penstock tubes leading to reduced nominal wall thickness.

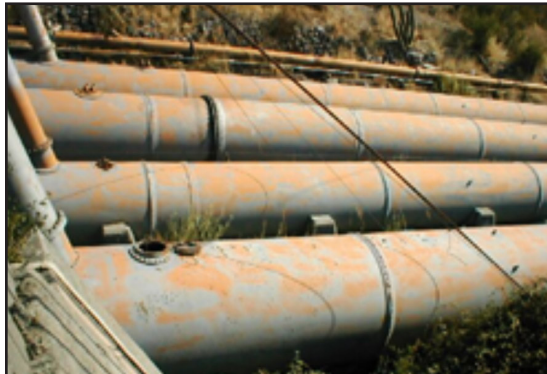
Penstocks viewed from outside

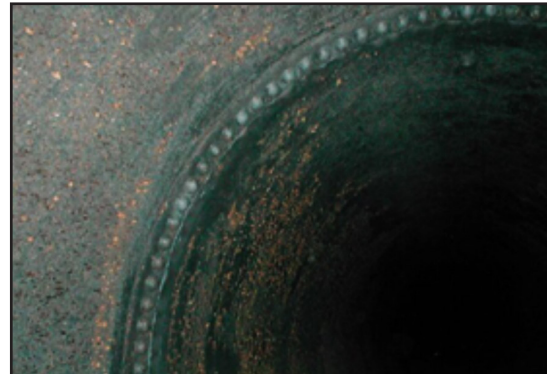
High suspended solids in water eroded older coating, leading to accelerated metal loss.

Pitting corrosion on penstock walls

- Pressure wash and decontaminate surfaces
- Grit blast to Sa 2.5 with 3 mil (75 µm) profile

1. **ARC 858** used to resurface heavily pitted and corroded area as well as to fare smooth the riveted pipe connections
2. Two coats of **ARC S2** applied in alternating color coats

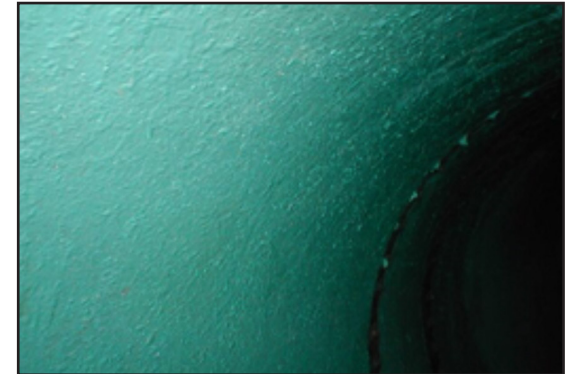
- After 10+ years in service the ARC linings continue to perform without flaws
- Annual inspections have been reduced to once every three years saving over \$65K/ inspection cycle
- As a result of this application three additional penstocks have been coated

ARC coated surfaces
