A 316 SS, well flow hydrocyclone severely pits and corrodes. Normal life of units is 4-5 years.

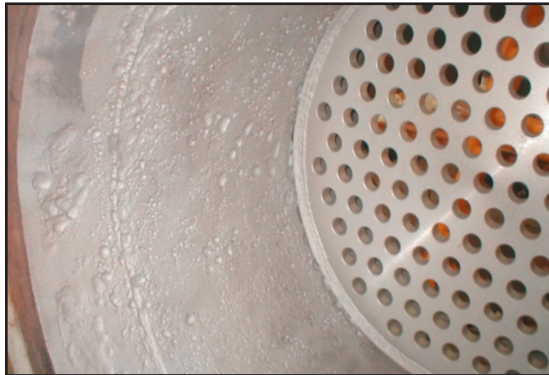
High chloride and solids concentration of solids and hydrocyclone turbulence.

After cleaning and decontamination, ARC 858 is applied to fill and smooth surface

- Grit blast to Sa 2.5 with 3 mil (75 µm) angular profile
- Treat to remove residual chlorides

1. Apply **ARC 858** to areas of severe corrosion pitting and rebuild smooth surface
2. Apply 2 coats of **ARC SD4i** with DFT of 750 to 30-40 mils (1000 µm) per coat for abrasion and corrosion protection and enhanced flow

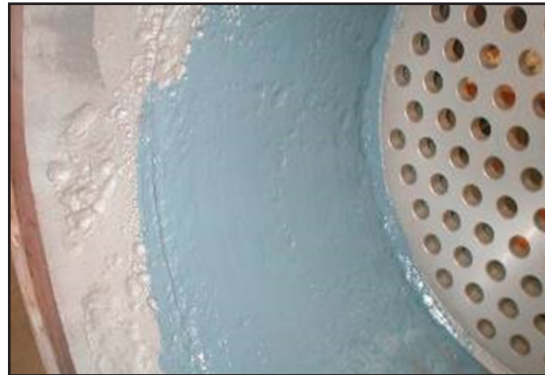
After application of ARC 858, ARC SD4i is applied for protection and enhanced flow efficiency

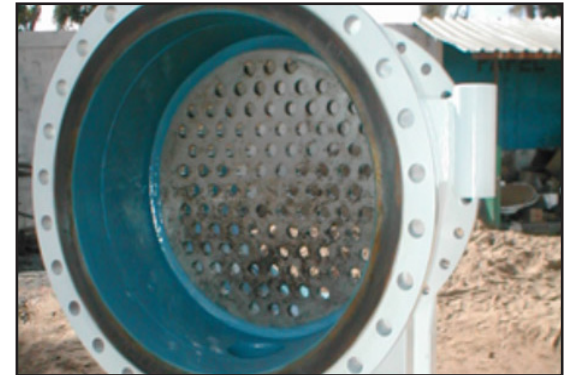
After cleaning and decontamination, ARC 858 is applied to fill and smooth surface
