Service life of 316 stainless liners in grinding mill less than 6 months.

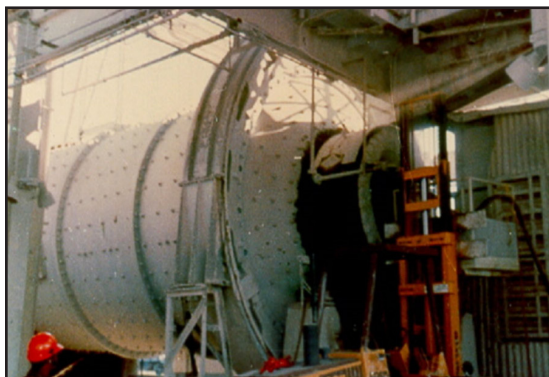
Mill and work area

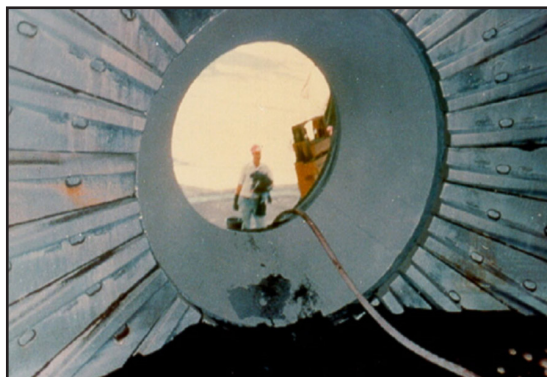
Prepared surfaces

- Pressure wash and decontaminate surfaces
- Grit blast to Sa 2.5 with 3 mil (75 µm) angular profile

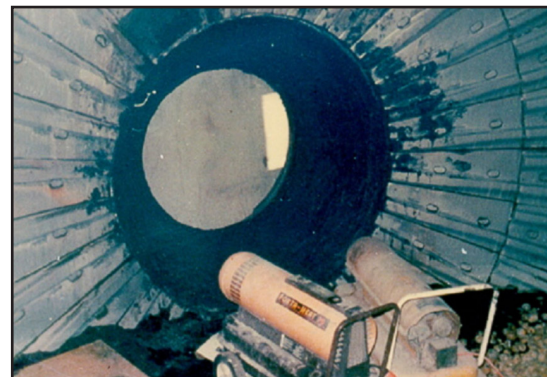
ARC coated surfaces being force cured in under 5 hours

1. Apply **ARC BX1\*** surfaces at ½" (12,8 mm) thickness
2. Force over with hot air after application
3. Cure time under 5 hours
