Challenge

Corrosion related damage required replacement of duct after only 4 years.

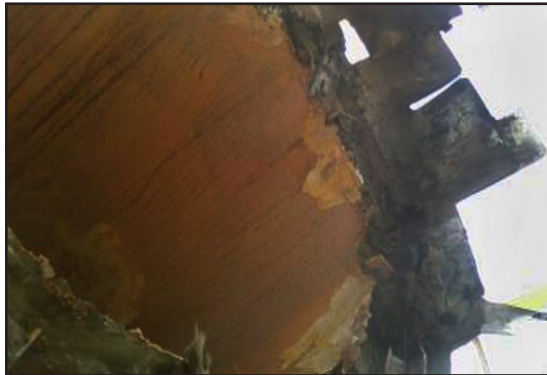
High concentrations of acids (H_2SO_4 and HF) at 266-320°F (130-160°C) condense on cool duct walls causing corrosion.

Transport pipe damaged by corrosive flue gas

- New carbon steel pipes were fabricated
- Grit blast to Sa 2.5 with 3 mil (75 μ m) angular profile

1. Apply [ARC 858](#) to the weld seams
2. Apply 2 coats of [ARC S7](#)

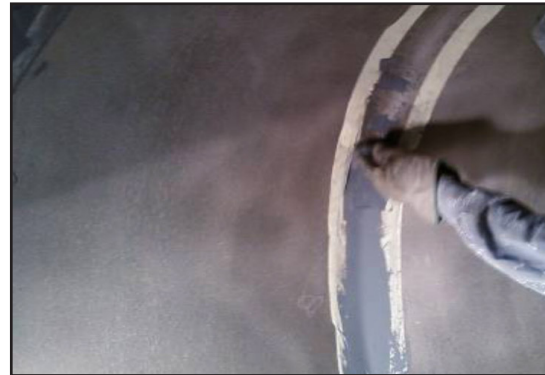
Applying ARC 858 to the weld seams

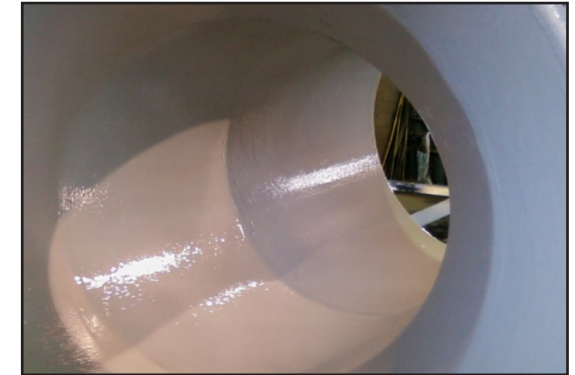
Client observed that ARC coating performed without degradation.

A finished section of ARC S7 pipe
