## Challenge

Reduced MTBR of cyclones required wear plate replacement every 4-5 months. Each repair took 4 days to complete, resulting in 288 hours lost production.

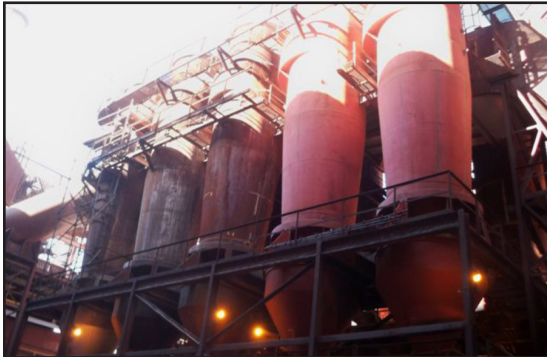
Sinter flow at high velocity and temperature wore weld overlay.

Severe abrasive wear typically repaired by welding in new wear plates every 4-5 months

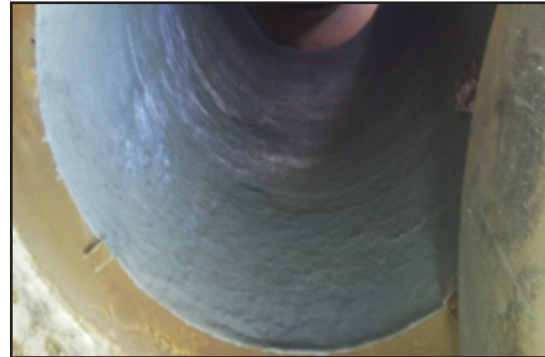
Application of ARC BX1\* in one of the cyclones at 6-8 mm

- Remove contaminants
- Grit blast to Sa 2.5 with 3 mil (75 μm) angular profile

- Trowel apply **ARC BX1\*** 6-8 mm (.25"-.3") DFT to the internal surfaces of the cyclone

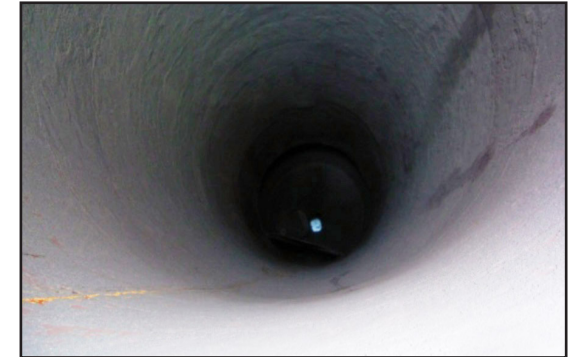
Minimal repairs required at 11 month inspection. In general <15% of lining thickness lost. All repairs completed within 24 hours.

After 11 months in service minimal wear is seen to the ARC BX1\*
