## Challenge

Reduced MTBR (22 days) of NiHard wear plate increased maintenance and spare parts carrying costs (\$27K/plate).

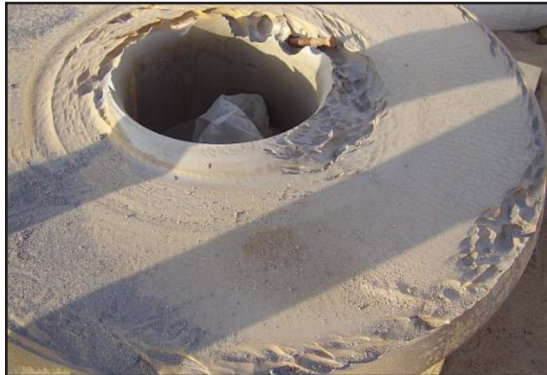
Abrasive fines in acidic tailings slurry wears NiHard plates.

Damaged wear plate at 22 days

- Grit blast to Sa 2.5 with 3 mil (75 µm) angular profile

1. Apply one coat **ARC S2** @ 10 mil (250 µm) as primer
2. Apply **ARC MX1** @ 500-600 mil (12-15 mm)
3. Apply two coats **ARC S2** @ 20 mil (500 µm) as overcoat

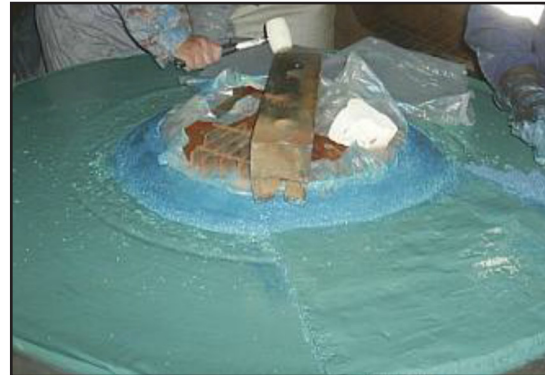
Applying ARC MX1 over primer coat of ARC S2

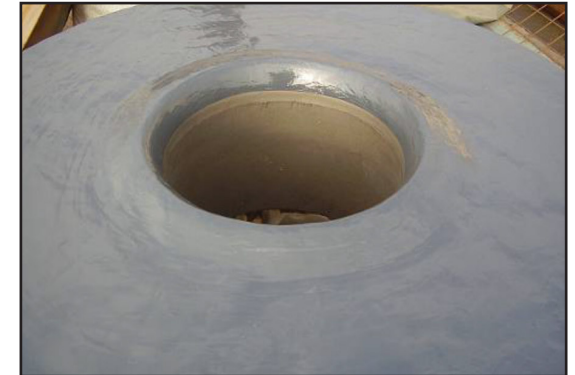
Completed wear plate ready for service
