Challenge

Issue

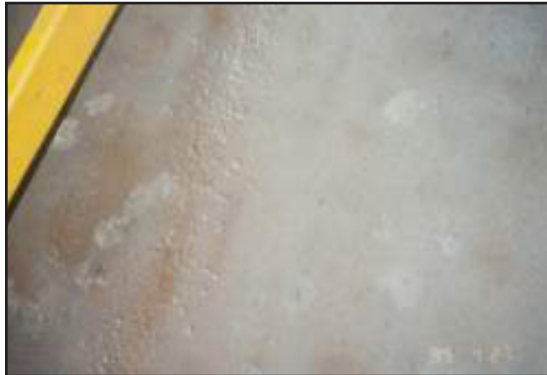
Failed coal tar coating resulted in pitting corrosion on face of gate. Corrosion kept gates from actuating and sealing correctly. Leakage down spillway channel creates icing in winter months.

- Galvanic corrosion

Corrosion and pitting on the spillway gate

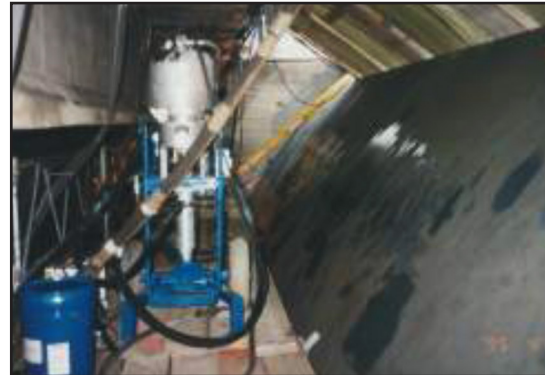
Pitting repaired using ARC 858

- Grit blast to Sa 2.5 with 3 mil (75 µm) angular profile

1. Apply **ARC 858** to rebuild pitted areas
2. Top coat with 2 coats of **ARC S2** @ total DFT of 20 mils (500 µm) to provide smooth flow efficient surface

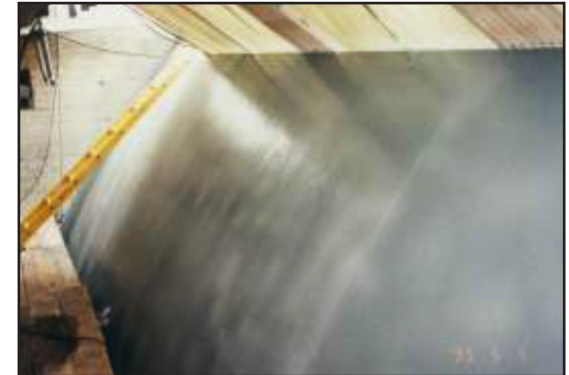
Gate top coated with 2 coats of ARC S2
