## Challenge

After three years in service, the leading edges of fiberglass blades became severely abraded. New blades cost \$8,000. The OEM repair method cost \$2,500 and had client concerned about rivet attachments breaking and repair cap delaminating.

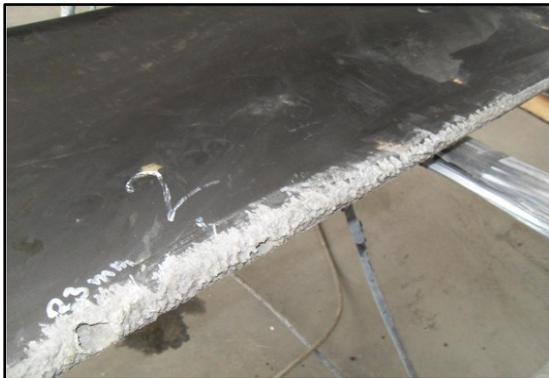
High-pressure water flow with airborne particulates wore the gel coat, leading to exposure of fiberglass reinforcement.

Before: worn blade.

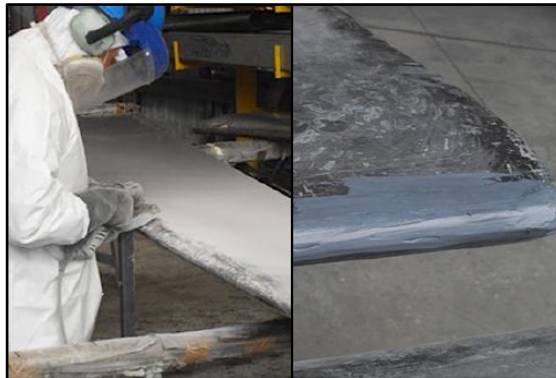
In process: blade in prep stages and partial ARC 858 repair.

Clean surfaces with [Chesterton 803 Industrial and Marine Solvent](#) and trim back exposed fiberglass and radial grind areas to be repaired. Wipe area to be repaired with solvent.

Spot patch repair the deep damage regions with manual application of [ARC 858](#). Follow with contoured gauge screed application of [ARC 858](#) to reproduce proper blade contour. Final topcoat of [ARC SD4i](#) applied for surface finish and restoration of gel coat.

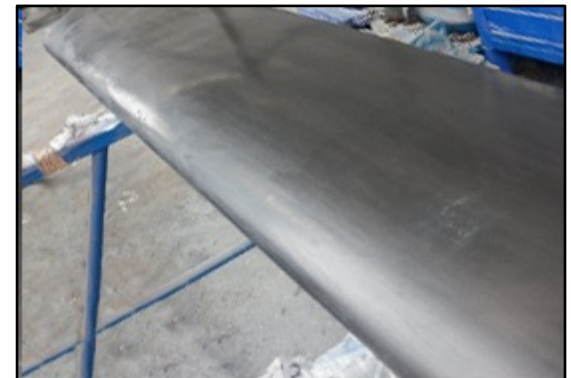
After: completed blade with ARC SD4i topcoat.
