The wear area of a 25" suction bell from a large vertical turbine pump was severely damaged.

The customer wanted this suction bell replaced but this involved a 16+ week lead time, so the customer asked a Chesterton partner to repair the pump with [ARC Industrial Coatings](#).

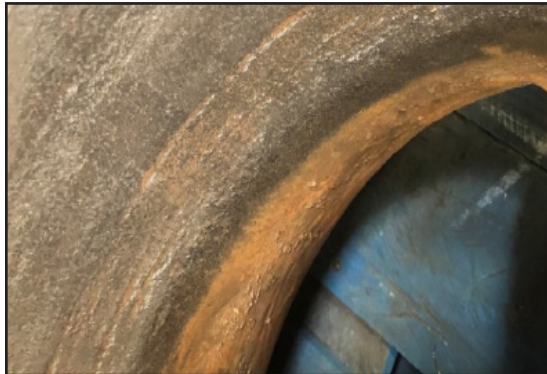
Influent water containing small amounts of suspended solids caused wear over the years of service.

Severely damaged suction bell before repaired with [ARC 858](#).

- Decontaminate surfaces, machine back the wear area.
- Grit blast to Sa 2 mils (75 µm) angular profile.

After machining the wear ring area, [Chesterton® ARC 858](#) was applied. The [ARC 858](#) is a 100% solids, thick film, ceramic reinforced abrasion control epoxy compound that can rebuild surfaces and protect against erosion. The Chesterton partner was able to repair the suction bell in only two days!

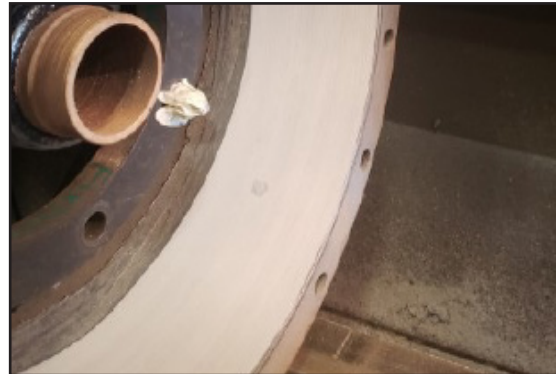
Suction bell being machined after [ARC 858](#) was applied.

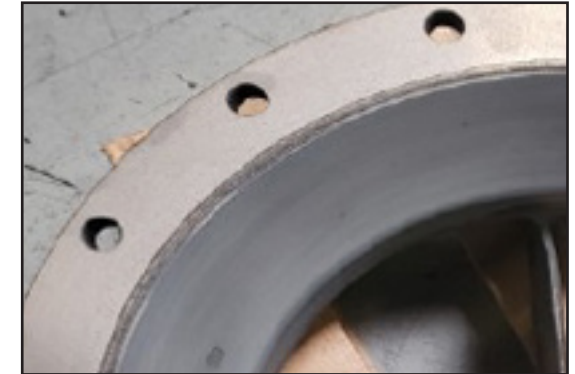
Suction bell successfully repaired with [ARC 858](#).
