Challenge

Background

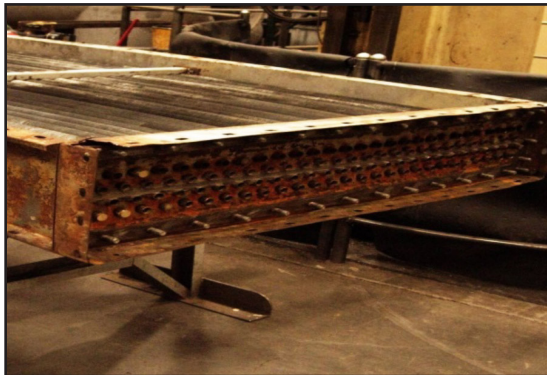
- Header leakage on a isophase cooling coil forced an unscheduled outage.
- The customer required a fast turnaround to repair the cooler. Time constraints would not permit replacement of isophase coils.
- The primary cause of the header leakage was rough, corroded sealing surfaces.

Corroded isophase cooler with rough and uneven surface.

- Chesterton 860™ Moldable Polymer Gasketing (MPG) to provide a seal on the rough surfaces.
- ARC 10 industrial coating to rebuild the damaged sealing surfaces.
- Installation was fast and easy.

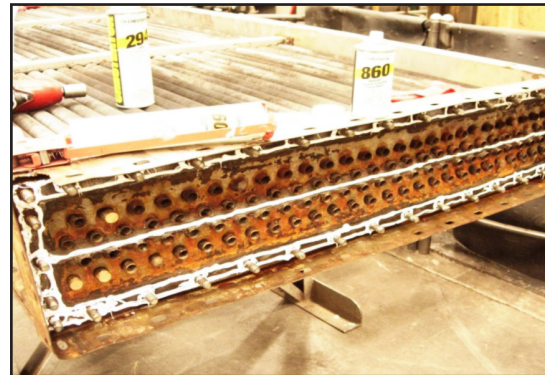
Surface is solvent cleaned with 294. Surface rust was mechanically removed before application of 860 MPG.

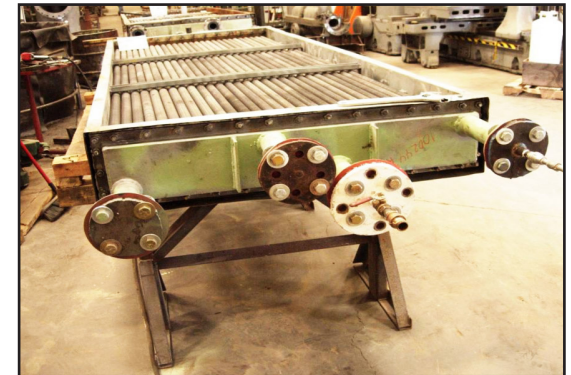
Unit being hydro-tested and readied for service.

- Chesterton 860 MPG was applied to the tube sheet channels and the water box. The unique 2-component sealant cured even in areas up to 6 mm thick.
- Cooler was then hydro-tested for 3 hours at 80 psi.
- Isophase cooler experienced no leaks and was put back in service.
- Customer was able to meet time constraints.
