Challenge

The degraded water quality affected the operation of the boiler water system.

Provide a long-term, permeation resistant coating eliminating water contamination.

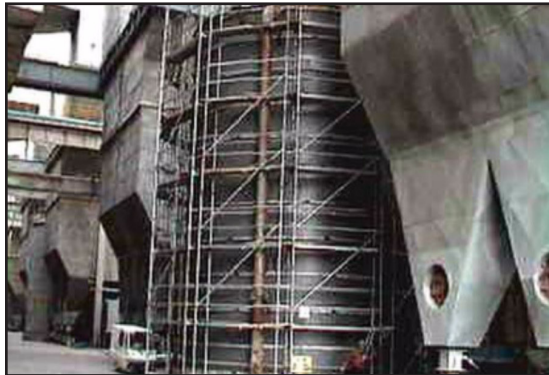
Coating permeation resulted in corrosion of substrate. Original tank coating failed in < 10 years. Resulting corrosion contaminating water with adverse impact to boiler.

Outside view of one of the tanks

- Grit blast remove old coating
- Replace structurally impaired, corroded steel plates
- Grit blast to Sa 2.5 with 3 mil (75 µm) angular profile

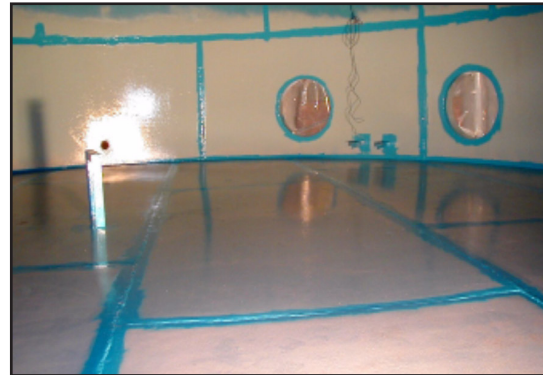
Stripe coating of the weld seams between the first and second coat of ARC S1PW

1. Spray apply first coat of **ARC S1PW**
2. Stripe coat weld seams with **ARC S1PW**
3. Spray apply second coat of **ARC S1PW**
4. Achieve DFT of 25 mils (650 µm)

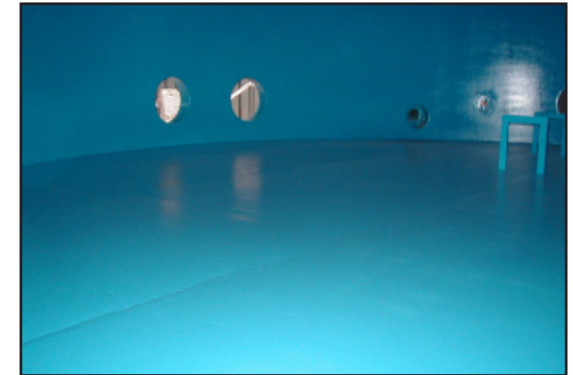
- 10+ years without blistering, cracking, or delamination
- No maintenance required since coating

View of the completed application
