## Challenge

- Provide an alternative to rubber lining
- Perform an in situ repair of significantly corroded large diameter cooling water pipes

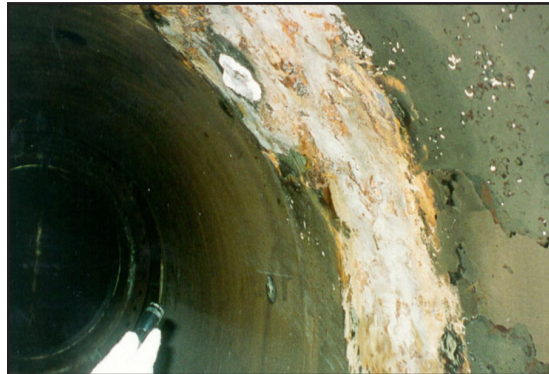
Due to failure of the existing rubber lining, the large diameter cooling water pipes were corroding and in danger of rupture.

Significant corrosion in area of failed rubber lining

1. Remove old rubber lining
2. Remove contaminants using water based cleaners
3. Grit blast to Sa 2.5 with 3 mil (75 µm) profile

- Apply **ARC 858** to all pitting and deeply corroded areas
- Apply 2 coats of **ARC 855** ceramic coating at DFT of 38 mils (900 µm) to existing piping and replacement sections

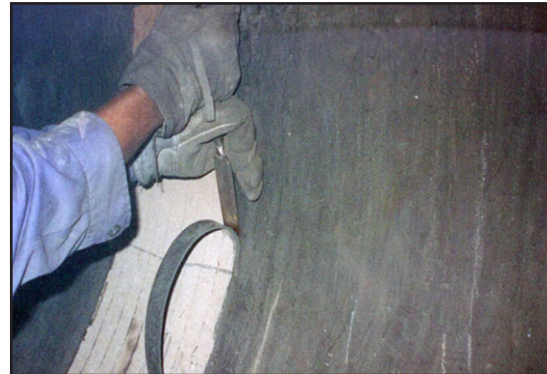
Rubber lining removal before cleaning

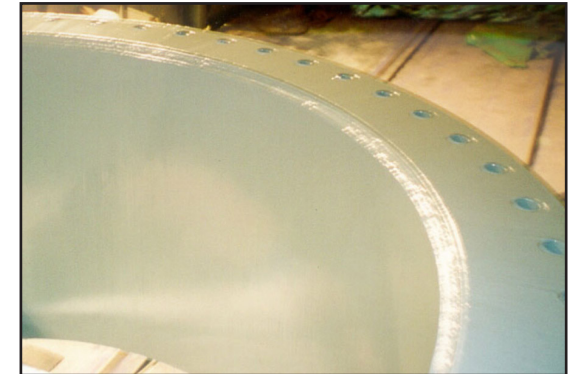
New stub-pipes grit-blasted coated with ARC 855, ARC 900 microns (35 mils)
