Challenge

Damage from abrasion to screw flyghts reduces coal transport efficiency by >10%, impacting plant production. Conventional weld repair provides 12 month MTBR.

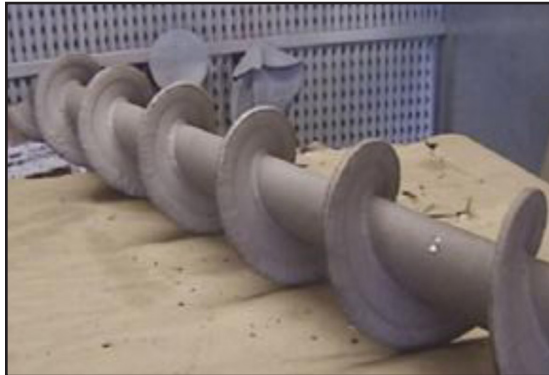
Abrasive and corrosive coal corrodes and wears flights, causing cracking and distortion of transport face.

Worn screw after first weld overlay and grit blasted ready for coating

- Grit blast to Sa 2.5 with 3 mil (75 µm) anchor profile

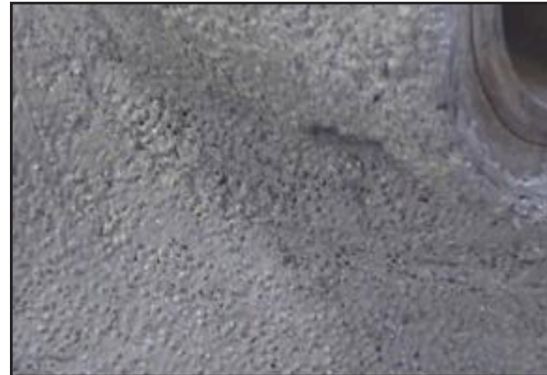
ARC BX1 is applied as severe duty wearing coat*

1. Apply **ARC BX1*** at 1/4"-3/8" (6.4-9.6 mm) on flight faces and drum to rebuild and protect
2. Apply **ARC 855** to reduce surface friction unit start up and initial run

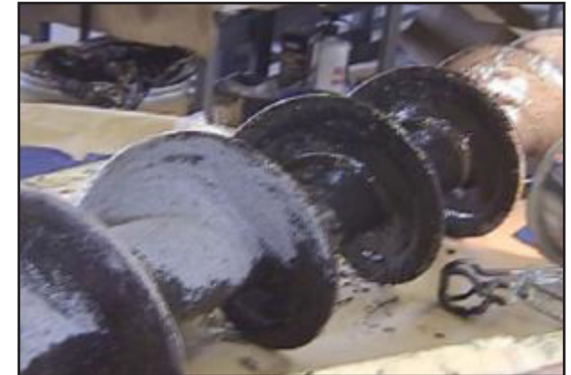
Completed screw coated with ARC BX1 and topcoat with ARC 855*

- ARC repair extended MTBR from 10-12 months to 18 months
