Challenge

Screen housing wore prematurely, leading to bypass of waste scrap and unscheduled downtime annual costs >\$110K.

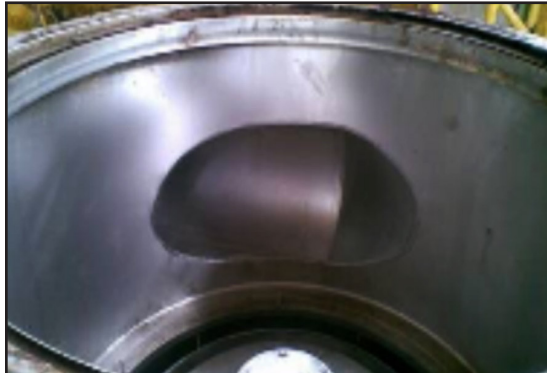
Trapped waste, including glass, sand, and metal particles carried downstream damaged primary screen housings.

Screen housing after surface prep

- Steam clean at 100 bar (1400 psi)
- Grit blast to Sa 2.5 with 3 mil (75 µm) angular profile

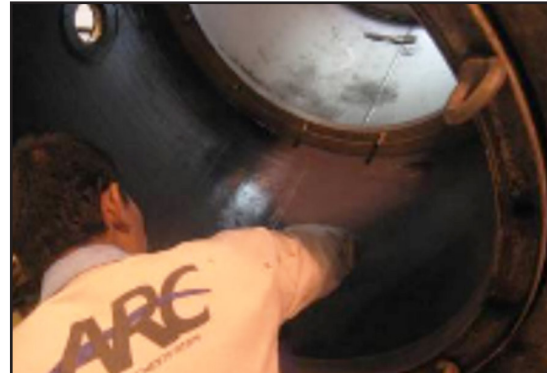
Application of ARC BX1*

1. Rebuild worn and scored areas with **ARC BX1***
2. Apply smoothing coat of **ARC 855**

*ARC BX1 is the "Bulk" package size of ARC 890

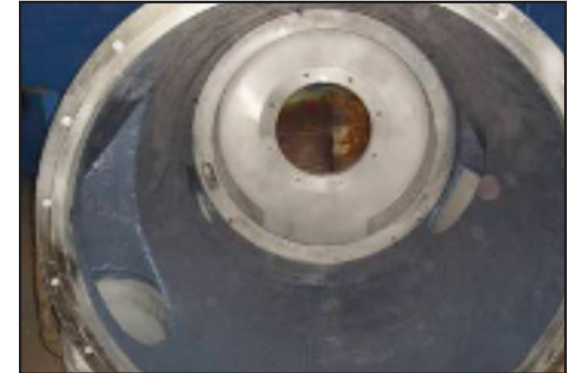
Housing protected with ARC BX1* and ARC 855

Screen life increased from 6 to >36 months. Inspection at 36 months showed >85% of original coating thickness remained.
