## Challenge

Nihard wear plates under discharge cones in hydrocyclone fail and must be scrapped and replaced at high cost with new plates every 15 days.

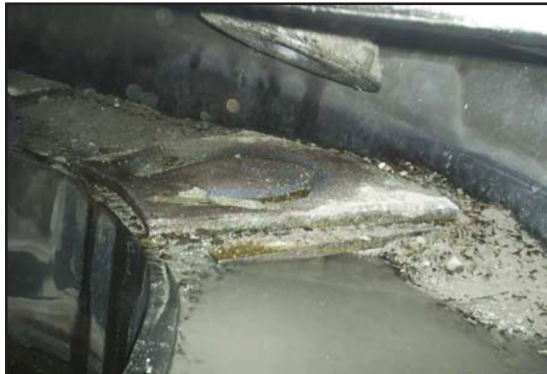
High velocity impact and abrasive wear from discharge of hydrocyclone.

Discharge cone above wear plate

- Pressure wash and decontaminate surfaces
- Abrasive blast to Sa 2.5 with 3 mil (75 µm) angular profile

1. Coat worn wear plates with **ARC BX1\*** to .25-.375" (6,4-9.8 mm) layer

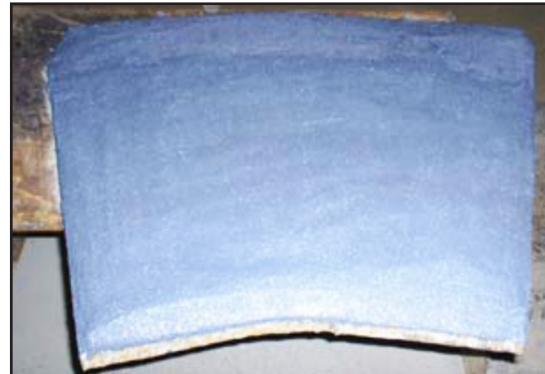
Freshly coated wear plate

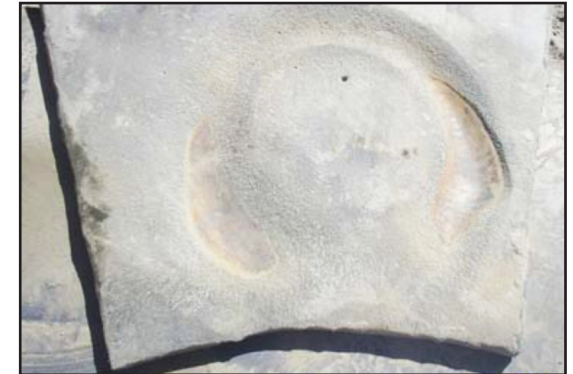
- 100% improvement in wear life of plates
- Plates are no longer scrapped and repurchased on a 15 day cycle
- ARC functions as "sacrificial coating" preserving original substrate
- Ability to repair and exchange reduced spare parts inventory of new wear plates by 90%
- As a result of success, client is standardizing **ARC BX1\*** in plant

ARC coated wear plate after 30 days
