## Challenge

### Goals

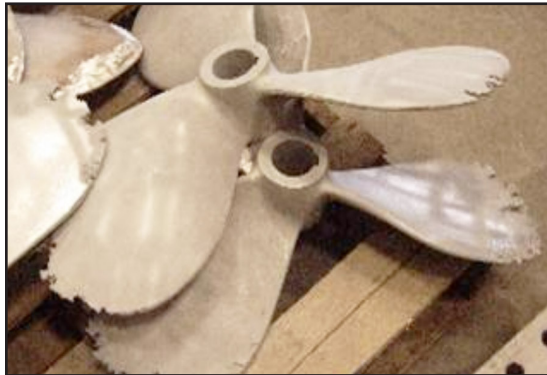
Highly abrasive slurry was resulting in severe erosion and metal loss in stainless steel agitators.

Severely abraded stainless steel agitators

- Weld repair damaged blades with 308 SS wire
- Dynamically balance blade after repair
- Steam clean at 100bar (1400 psi)
- Verify surface free of soluble salts
- Grit blast to Sa 2.5 with 3 mil (75 µm) profile

1. Apply 4-5 mm of **ARC BX2\*** to leading edges and 3-4 mm of **ARC BX2\*** to blade faces
2. Dynamically balance blades after cure

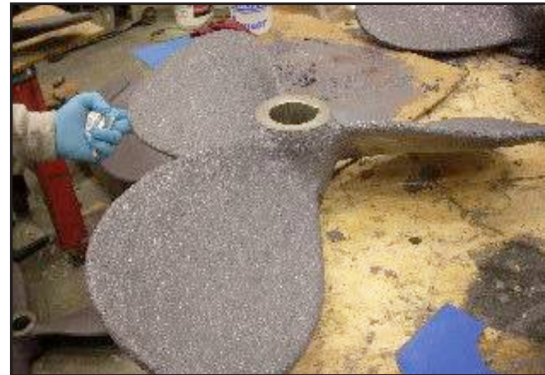
Applying ARC BX2\* being applied to the agitator

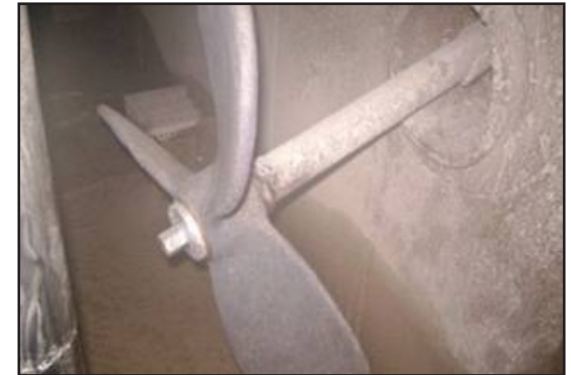
ARC ceramic coatings exceeded the previous 6-month MTBR.

Completed agitator installed in tank
