Challenge

Severe external corrosion was causing client to consider complete pipe replacement for primary influent lines.

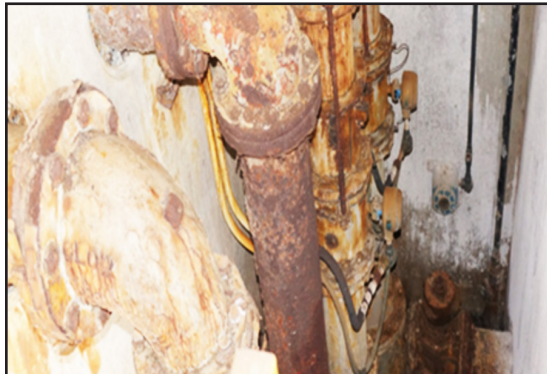
Condensation from cool water inside pipes and hot ambient atmosphere in plant resulted in exfoliation corrosion on exterior of pipes.

Corroded pipes

- Wire brush clean surfaces to Sa 2.5 expose pre-existing profile

1. Immediately following preparation apply **ARC 797** before condensation caused flash rusting
2. At tack free cure stage, apply 2 coats of **ARC S2** were applied following overcoat window

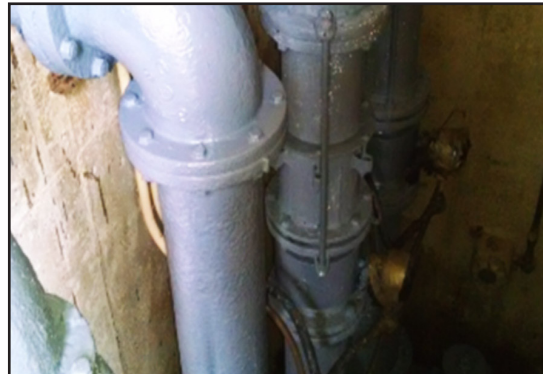
Coated pipes

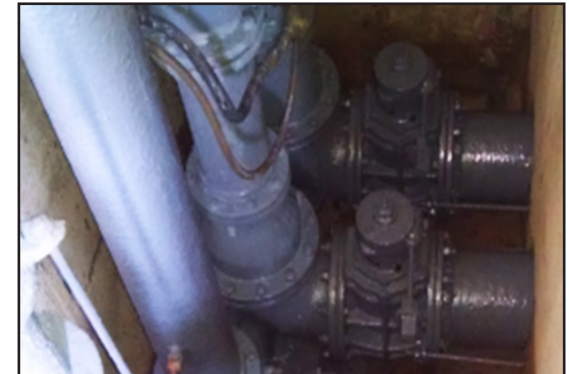
- Due to the success of this application replacement of these pipes (which are responsible for 500 MGD of flow) has been avoided
- Replacement would have jeopardized wastewater flow for as much as three weeks

Coated pipes
