Challenge

Failed coating led to pitting corrosion of structural steel at bearing housing interface, resulting in lubricating oil leaking into river. This creates an environmental hazard and possible fines for pollution.

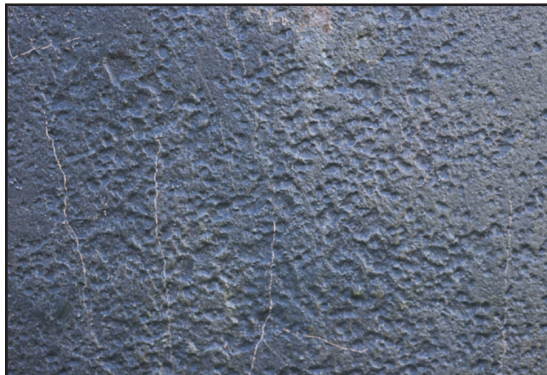
Severe corrosion of the steel structure had damaged the bearings, resulting in leaking of lubricating oil into the Danube River.

Pitting corrosion on structural steel

- Grit blast to Sa 2.5 with 3 mil (75 µm) angular profile

1. Apply 2 coats of **ARC 855** @ 15-20 mils (375-500 µm) per coat

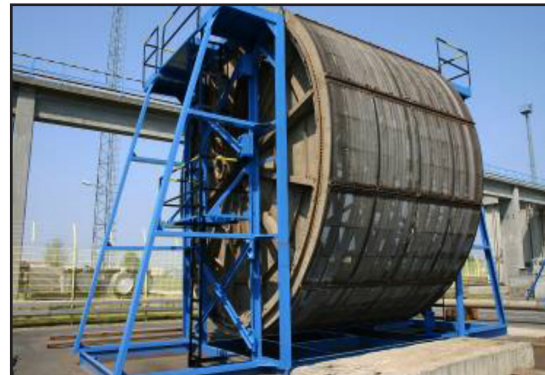
The drum screen prior to protection

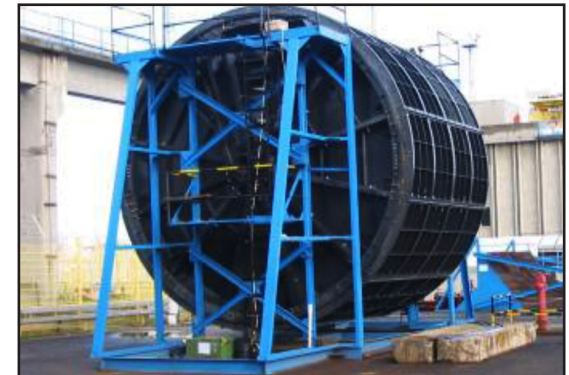
Completed application including ARC protection, and new shaft seals and bearing protection
