## Challenge

Corrosion and abrasion of tile and coated frothing cell reduced reliability and efficiency of frothing cells, impacting production at coal preparation plant after only 18 months.

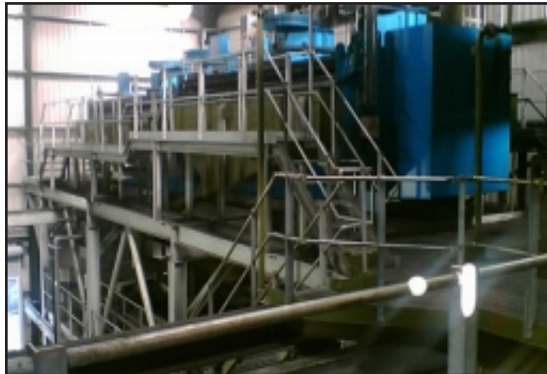
Agitated coal fines in water/hydrocarbon froth erode ceramic tile grout and corrode steel shell internals.

Frothing Cell

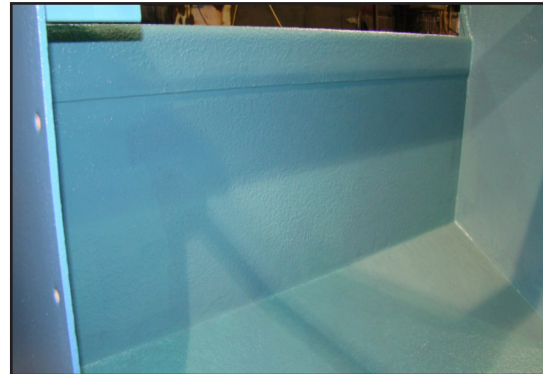
ARC BX2\* top coated with ARC S2

1. Apply **ARC BX2\*** as tile grout directly under draft tube
2. Apply **ARC BX2\*** to sloped/vertical internal surfaces @ 1/8 inch (3 mm)
3. Apply **ARC S2** over **BX2\*** @ 10-15 mils (500-750 µm)
4. Apply 2 coats of **ARC S1PW** to the external surfaces. Total ~DFT: 30 mils (750 µm)

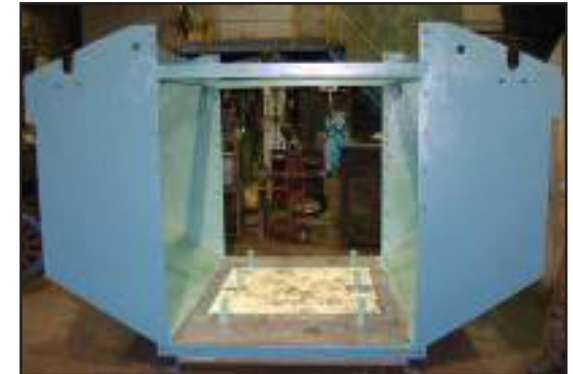
Frothing cell after ARC S1PW on outside
