Challenge

Contamination from aging rubber lining created water quality issues that impacted steam-generation equipment.

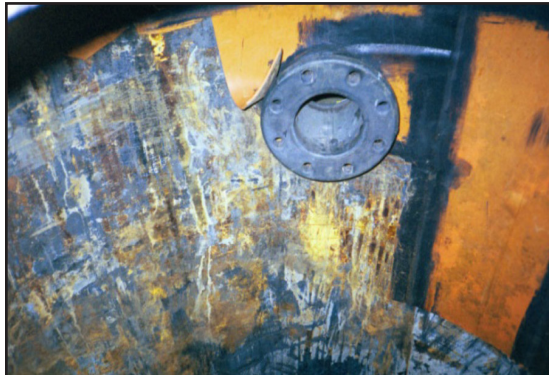
Aged vulcanized rubber lining leaches sulfur into demineralized water.

Removal of the rubber lining in progress. Blistering of the lining is visible

- Hydro blast remove rubber lining
- Grit blast to Sa 2.5 with 3 mil (75 µm) angular profile

1. Apply **ARC 858** to restore and smooth surface
2. Apply 2 coats of **ARC S4+** @ total DFT 25-30 mils (630-750 µm)

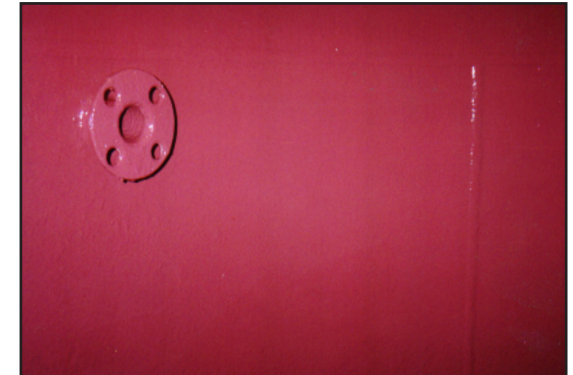
After proper surface preparation, ARC S4+ was applied in a two-coat system

- After coating, filled vessels require no flush or rinse to remove residual contamination
- In operation, the vessels showed sulfur levels not greater than 1 ppb
- Lining has been in service for >5 years
