Challenge

Severe corrosion to failing acid brick lined concrete basin resulted in leaks and environmental fines

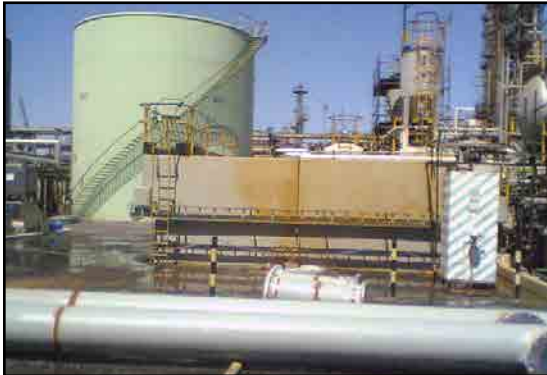
Sulfuric and hydrochloric acids degrading mortar and grout lines

Basin in petrochemical complex

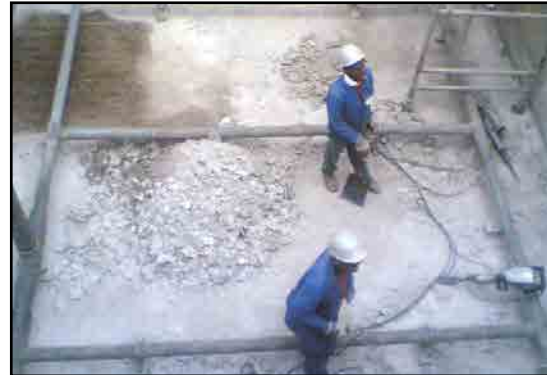
Surface preparation

- Old acid brick was removed as well as damaged concrete.
- Surfaces abrasive grit blasted and alkaline washed

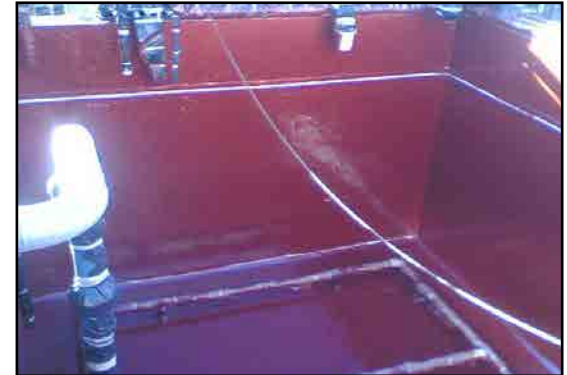
ARC CS4 final application

- Cementitious mortar used to re-surface damaged concrete
- All surfaces coated with 2 coats of **ARC CS4** at 15-20 mil (375-500 μm)/coat
