Excessive abrasive wear to suction spool on limestone recirculation pump for flue gas desulfurization after <30,000 hours reduced flow to spray nozzels

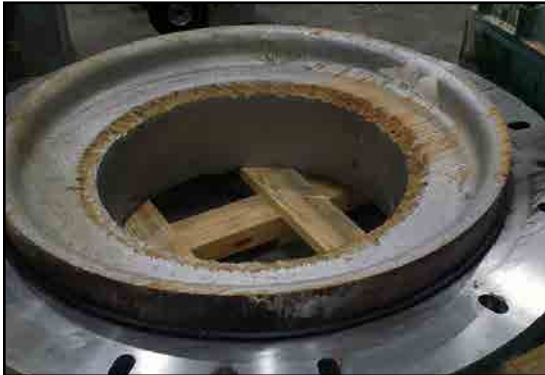
15-20% limestone slurry in corrosive carrier attacked super duplex stainless

Suction spool after 30,000 hours

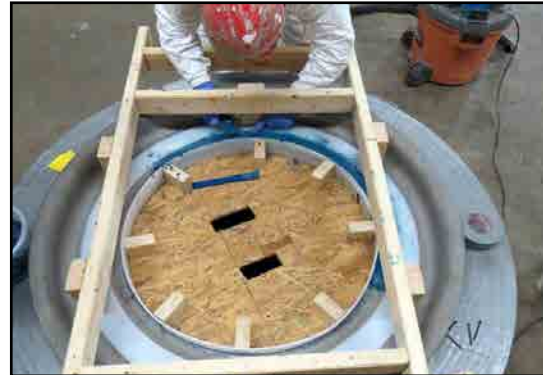
Installing ARC coating to wear region

- Mold was prepared using new spool section
- Grit blast to Sa 2.5 with 3 mil (75 µm) angular profile

- Install mold section and apply **ARC MX1** to suction spool at 240-350 mil (6-9 mm)
- Topcoat with **ARC SD4i** at 15-20 mil (375-500 µm)

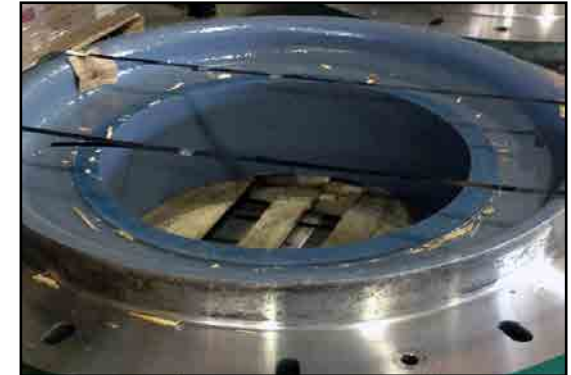
Repaired unit ready for install

- Repairs carried out in <1 week compared to >6 week lead time for spare parts
- Spools in service now for >6000 hours, showing no sign of abrasive wear
