The discharge hopper on a barge experienced corrosion/abrasion loss resulting in weld cladding with a cost of >\$475,000.

Provide alternative protection with cost savings and equal to or better performance.

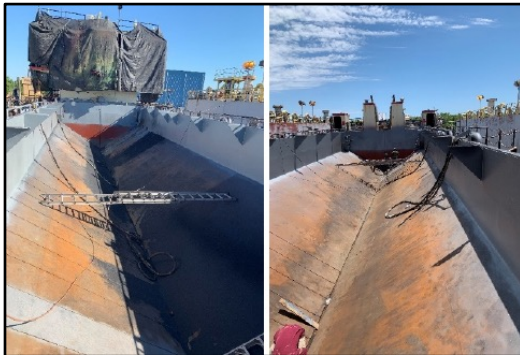
High salinity from tidal operations along with intermittent wet/dry exposure and abrasive action associated with dredging resulted in high metal loss conditions.

Before: dredge hopper after initial coarse blast.

High-pressure water wash to remove chlorides followed by coarse abrasive blast to SP10 cleanliness, with 3+ mil profile. Alternating strips were sweep blasted each day to get back to SP10 cleanliness. A 3/8" screed guide strips tack welded 36" apart to provide guide to lay down ARC BX1 at proper thickness for trowel finish.

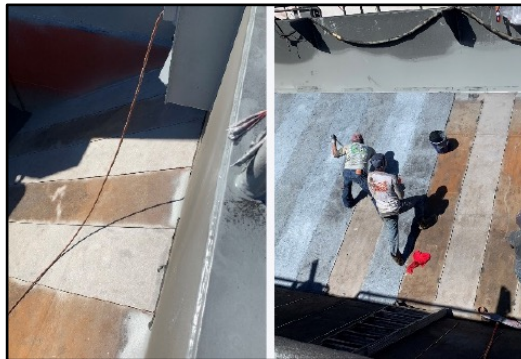
In process: screed strips welded to plate and application progressing.

Applied ARC BX1 by screed guide/strip method and then trowel finished to a smooth, closed surface.

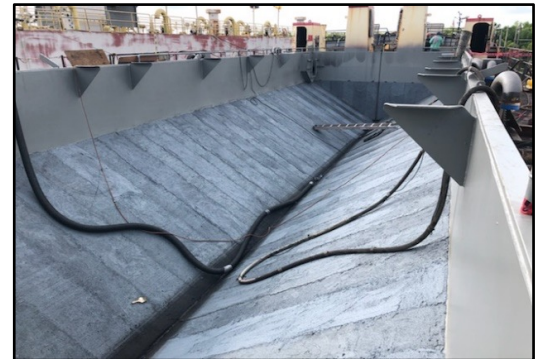
After: completed discharge hopper.

Ship captain had previously used ARC BX1 to line dredge pumps with great results. That experience prompted him recommend to ship owner to try ARC BX1 on discharge hopper. Dry dock was reduced by 50% and cost of labor and materials to coat was 20% less than clad and weld approach.
