Challenge

Discharge launderer rings below hydrocyclone experienced severe impact abrasion causing ceramic tiles to fail.

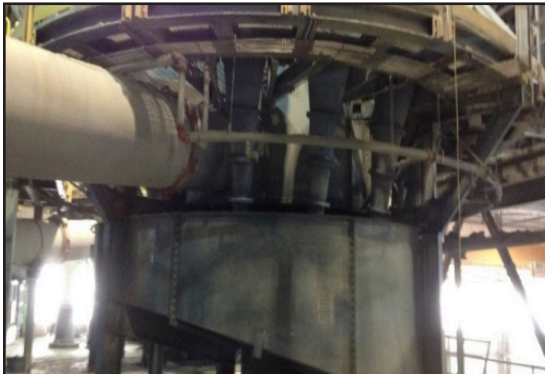
Krebs Cyclone

High-impact, flow-induced, slurry abrasion

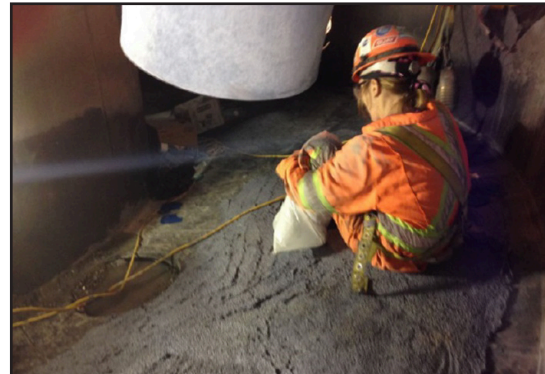
Previous product application

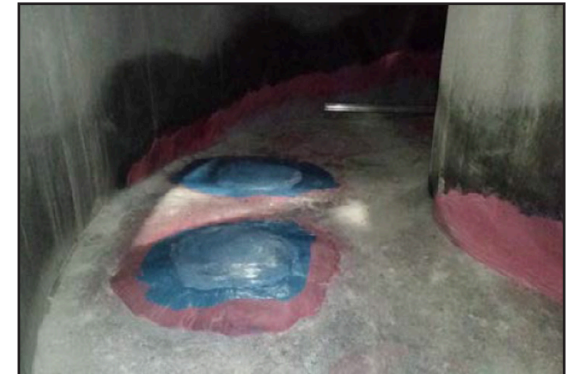
Expertly trained ARC Certified application

Surfaces cleaned with High Press water then mechanically abraded to roughen surfaces to SP11 cleanliness with 2 + mil profile.

ARC I BX1 was initially applied on all exposed surfaces. After a six-month inspection, the impingment area directly below the discharge cone was upgraded with **ARC MX1** based on our recommendation.
