A large fish processing facility was experiencing contamination of liquid fertilizer due to corrosion on carbon steel tanks.

Eliminate source of contamination and extend the service life of the storage tank against further corrosion losses.

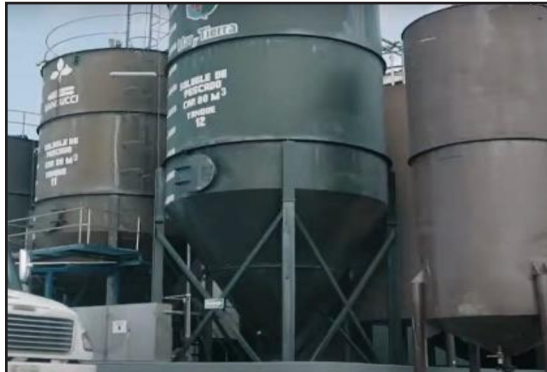
Mild acid is added to tank contents to prevent fermentation and control storage. This mild acid reacts with unlined carbon steel resulting in corrosion and scale, contaminating tank contents.

Liquid fertilizer storage tanks before maintenance.

The tanks were prepared for maintenance by decontaminating surfaces, grit blast to Sa 3 with 3 mil (75 µm) angular profile.

Chesterton® ARC S3 was applied to a total thickness of 30 mil (750 µm) through an airless pump. Two coats of 15 mils each were applied.

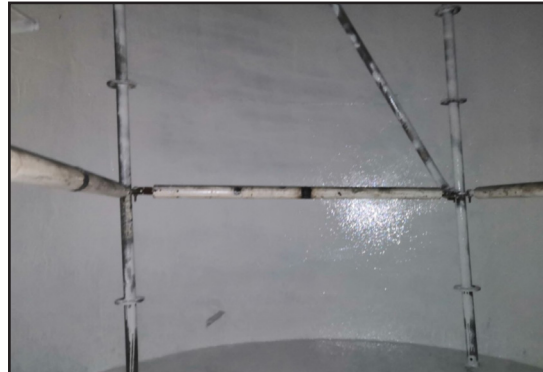
ARC S3 applied to interior of carbon steel tank.

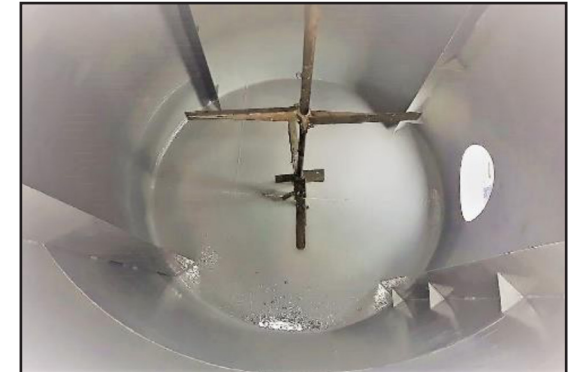
Tank interior after ARC S3 application.

After using ARC S3 to protect the tanks, the customer was able to save significant maintenance costs. The alternative cost of preventing corrosion was stainless steel cladding. The repair using ARC S3 was 1/6th the cost of the alternative method.
