Split Polymer Labyrinth Seal Solves Huge Leakage Problem

A flood remediation station was refurbishing all of their large water pumps to improve the reliability of the pumping station.

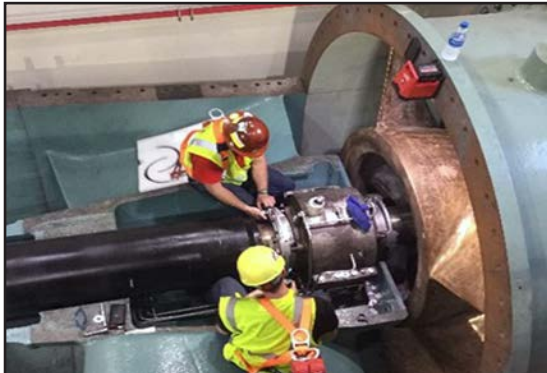
Refurbishing water remediation pump.

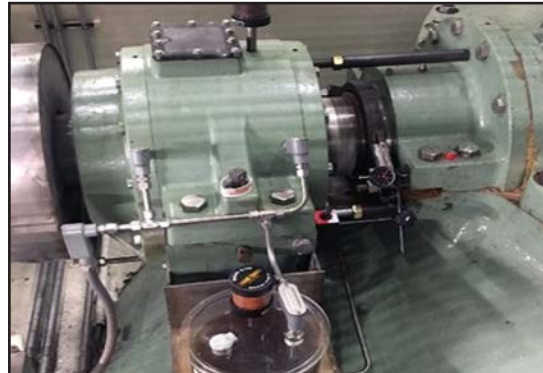
The initial seals installed were oversized and leaking excessive amounts of lubricant from the bearing housing. The machines were too large to dismantle. The customer wanted a simple split bearing seal that would help to eliminate shaft wear typically experienced with lip seals.

Bearing housing.

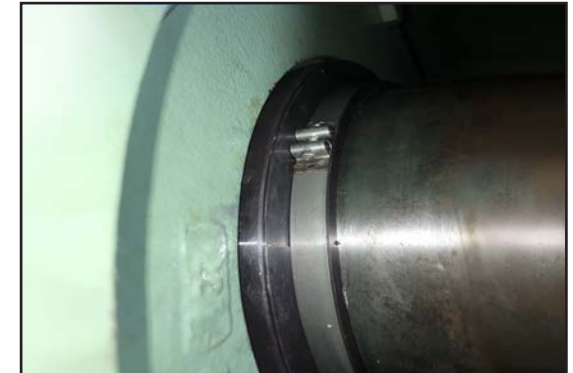
Split Polymer Labyrinth Seal installed.

Chesterton® Split Polymer Labyrinth Seals (PLS) were installed on both ends of the bearing housing.

The Split PLS were simple to install, taking less than 30 minutes to prepare the shaft, install each seal, and test.

This design incorporates an automatic shutoff device, which prevents water and particulates from contaminating the bearing housing when the pump is shut down.

Seals are split radially in only one cross-section, which reduces potential leak paths.

Polymer flexibility allows for easy installation by twisting the stator and rotor.
