Challenge

A continuous surface lignite mine was facing issues with boom lowering hydraulic cylinders of compact type bucket-wheel excavator. Only a few years into operation, the cylinders were experiencing continuous leakage and malfunction (piston seal by-pass).

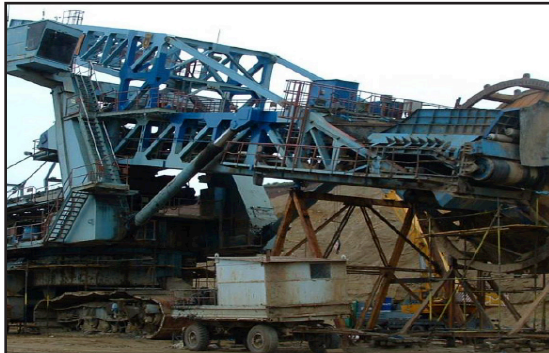
The large diameter cylinders were exposed to heavy payload, shock load, pressure peaks, and deflection by long stroke and angle position.

Compact lignite bucket-wheel excavator.

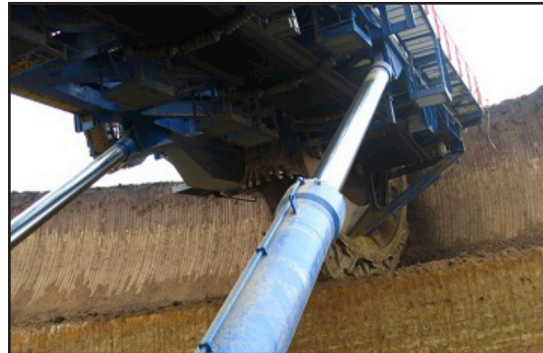
Bucket-wheel boom lowering cylinders in operation.

The Chesterton team developed a seal system that was installed during a planned overhaul.

The sealing solution included a **5K Wiper, 10K Rod Seal, 10K Piston Seals, and replaceable 19K Bearing Bands**. A combination of innovative sealing materials was used:

- **AWC800** proprietary polymer: Best-in class sealing technology with high wear and abrasion and extrusion resistance.
- **AWC660**: A high loading capacity, engineered plastic with built-in lubricants that prevent metal-to-metal scoring and prolong equipment life.

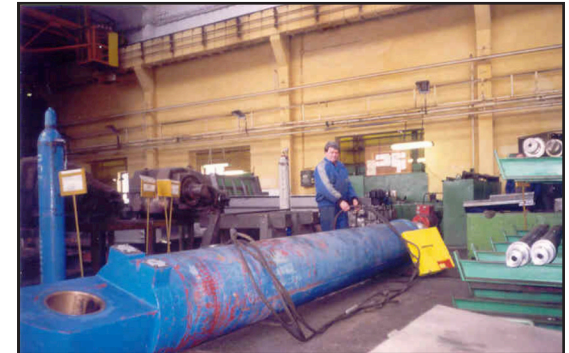
Boom lowering cylinders in repair shop.
