## Challenge

At a large wood-based panel plant, the customer experienced excessive leakage of hydraulic oil from the main press cylinders of a single-daylight laminating press. The leak rate caused press operational problems, product quality issues, and safety/environmental concerns.

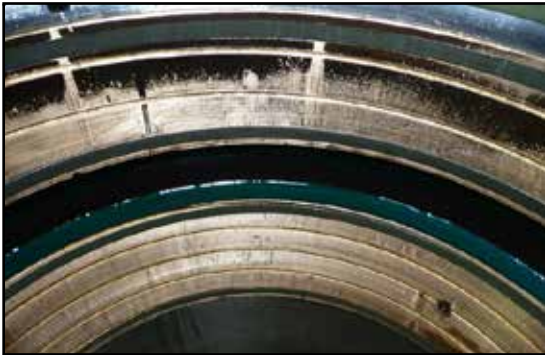
The existing top and bottom bronze bushings of the rams were worn out by excessive lateral load on the cylinders and by the high cycle numbers of press cycles. Further heavy scoring of the rams and bushings was observed as well. The radial movement caused extrusion and excessive deformations of the rod seal that led to continuous leakage.

*Worn, scored ram bushings (with spiral oil grooves).*

The Chesterton sales specialist recommended refurbishment based on failure analysis of the seals and equipment inspection. The technical proposal was accepted by the customer and the re-machining of the bronze bushings was made according to technical drawings.

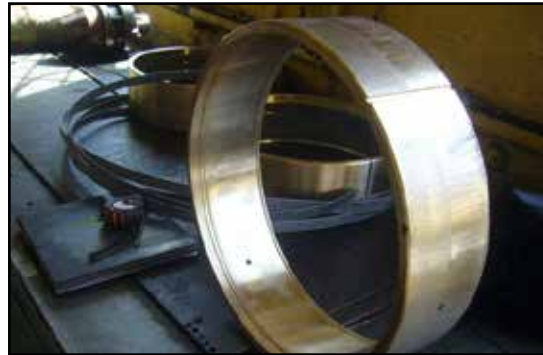
*Bearing groove being machined in the old bushing.*

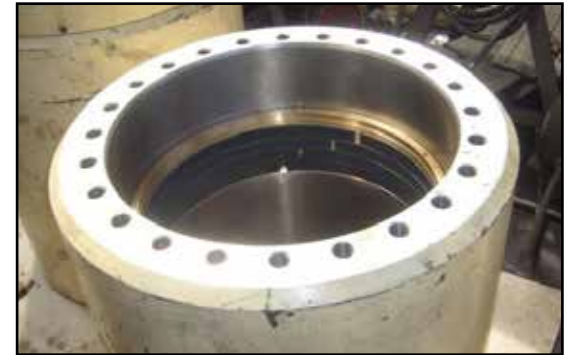
*16K cut wear rings are installed in the groove.*

The Chesterton 16K Non-Metallic Wear Rings have exceptional physical properties with high bearing capacity, supporting heavy lateral loads. The built-in lubricants help reduce friction between mating surfaces. This extends equipment and seal life, and provides smooth, parallel motion of the press cylinders. (Ram diameter 430 mm (16.93')

The Chesterton 16K Wear Rings were installed in the spring of 2011. The main press cylinders have been in operation without disruption for over 6 years, providing reliable and smooth operation for the laminating press line.
