Two Vertical Turbine Pumps Saved with Split Seal Replacement

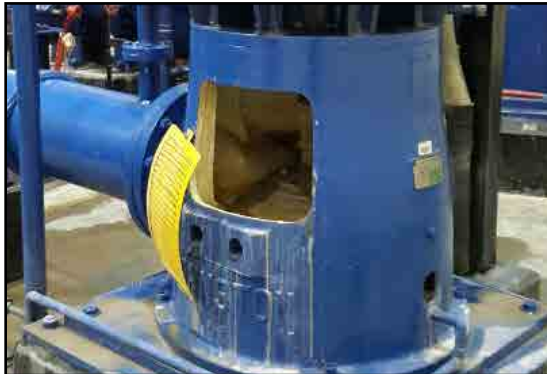
A large city water plant in Canada had two vertical turbine pumps with a shaft that was extremely damaged from packing (no sleeve). The pumps leaked excessively, and the customer was preparing to send them to the scrap pile. The Chesterton representative convinced them to try **Chesterton 442C split seals**, which could be installed over the damaged shaft and did not require disassembly of the pump.

The pump shafts were extremely damaged.

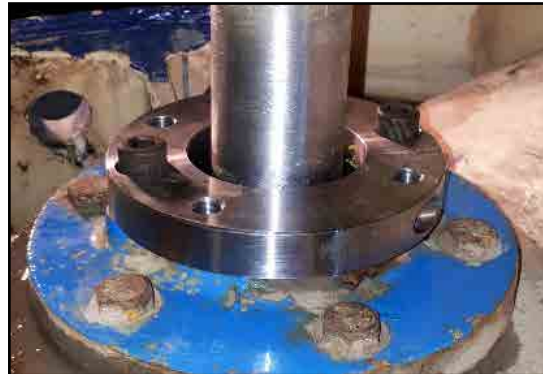
The 442 seal was adapted to fit the stuffing box.

Dimensions were taken, and the **442C** required adapters to fit the stuffing box dimension, which were manufactured in a local shop.

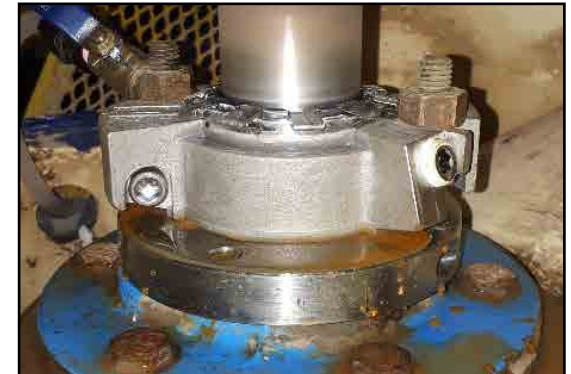
The split seal is running effectively with no maintenance required.

The two **442C** split seals were installed in December 2017 and are still running efficiently and without leakage. The customer has plans to purchase two more.
