Challenge

A desalination unit of a power plant in the Middle East was having issues with a vertical pump handling brine. The gland packing used to seal the pump was wearing out the shaft sleeve and causing massive leakage. The plant could not stop the pump or overhaul it, especially during the hot summer days. The pump operated at RPM 490, with pressure of 7.5 bars, and a maximum temperature of 50°C.

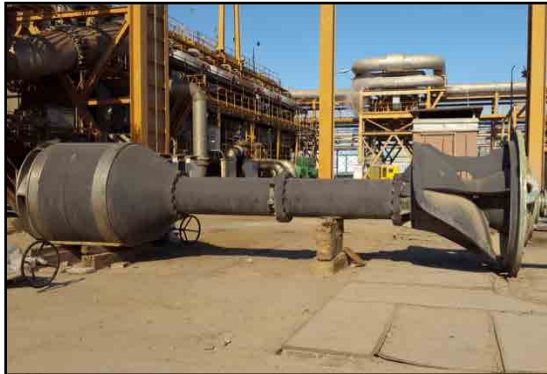
Brine vertical pump being serviced for repairs.

Chesterton representatives recommended the **Chesterton 442** split seal which can be installed in less than one day.

The pump was sealed with **Chesterton 442** size 280M RSC/RSC EP A2205 plus **SpiralTrac™** Split Adapter (brass) active throat bushing. The **SpiralTrac** adapter allows installation of the **442** in big bore pumps without the need for pump modification. Since brine is a heavy crystallizing media, **SpiralTrac** will help remove the accumulated crystals from the stuffing box for increased reliability.

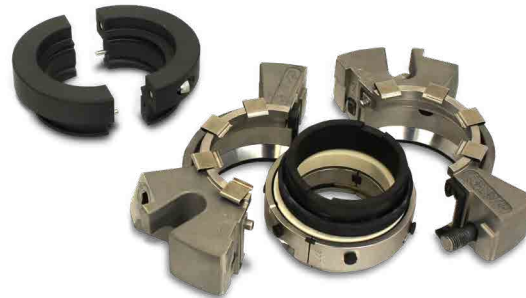
SpiralTrac and Chesterton 442 solutions.

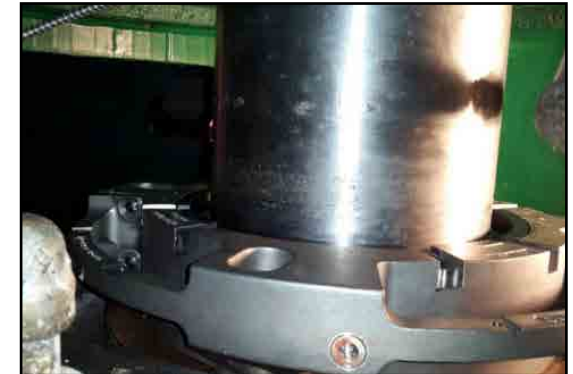
The installation was completed successfully in only six hours vs. the week of downtime it would have cost to dismantle the pump to replace the packing/shaft sleeve.

The pump was commissioned and started up virtually leak free.

With less packing friction, the plant estimated 5 – 8% power savings with the **442** split seal solution.

Vertical pump installed with 442.
