Challenge

A customer in the food and beverage industry had issues sealing a mixer in an application which mixed chocolate with other additives such as nuts and caramel. The bottom shaft rotated at speeds up to 1500 rpm. The original seals were failing nearly every five days, causing the mixture to leak and resulting in product loss. This situation also required ongoing maintenance issues.

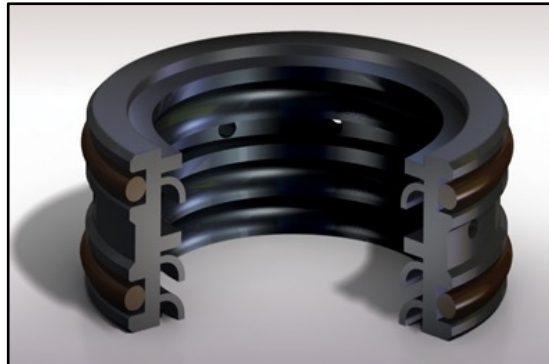
Chesterton 30KC Cartridge Multi Lip Seal.

A Chesterton® 30KC Cartridge Multi Lip Seal was used to run against the shaft. The seal was made of carbon/graphite filled PTFE for excellent wear performance. The cartridge was installed in a stainless steel can to provide positive radial and axial retention. Flush ports were provided in both the seal and can to allow effective cleaning and periodic infusion with a FDA compliant lubricant.

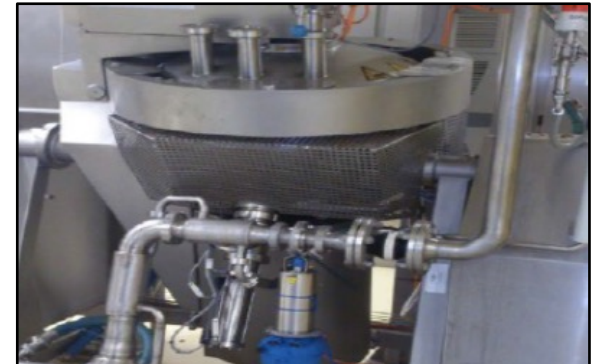
The chocolate mixer sealing issues were resolved.

The 30KC performance was verified through functional trial in the customer's mixer. After 12 months of problem-free performance, the customer switched to this solution. The Chesterton 30KC Cartridge Multi Lip Seal provided successful sealing for another two years before maintenance was required.
