Challenge

Wicket gates at a large hydropower plant were leaking – leading to unplanned maintenance, environmental, and safety concerns.

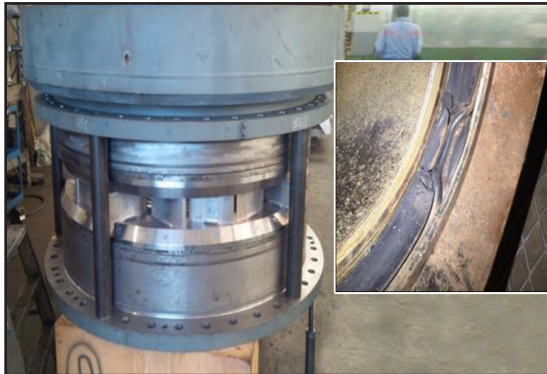
A competitor's rubber U-cup seals had to be replaced regularly a maximum of every two years. This resulted in shutdowns, extra maintenance costs, and lost production.

Wicket gate cylinder being rebuilt.
Insert: damaged rubber u-cup seal

Chesterton 22KE, single continuous U-cup, which incorporates the use of an O-ring to increase pre-load capabilities, energizes the seal in the absence of system pressure while providing added stability during operation.

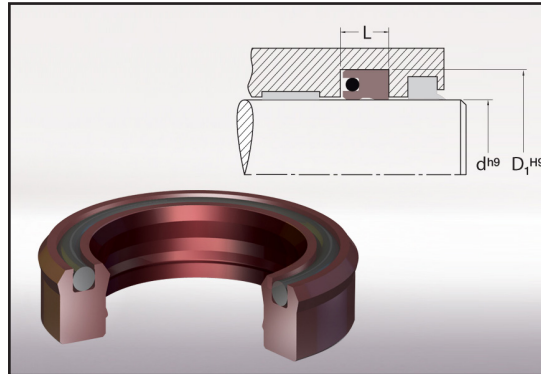
The seal material is **AWC 800**, a proprietary thermoset polymer that offers excellent abrasion and hydrolysis resistance for reliable performance in these challenging hydraulic applications.

Chesterton 22KE with an o-ring energizer and high performance AWC 800 polymer materials.

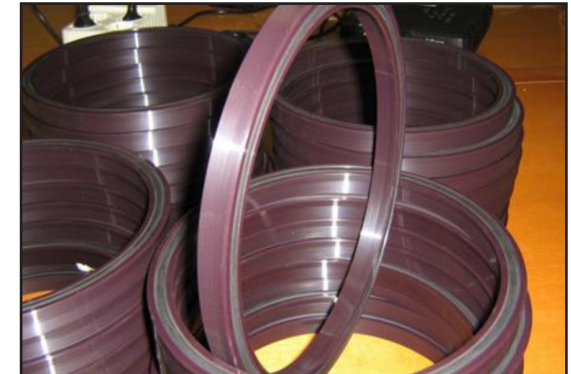
Chesterton R22KE – Unique lip geometry stabilizes seal to prevent rolling and to ease installation.
