Challenge

Background

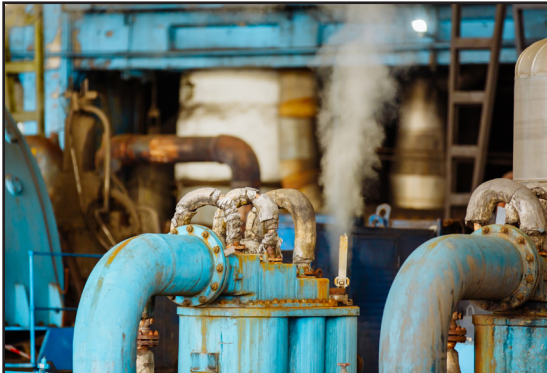
Time-consuming disassembly of flanges on pipes and other equipment.

A maintenance unit at a refinery was facing numerous dismantling issues, particularly with threaded rods on bolted flange assemblies of pressure and piping equipment operating at high temperatures. Disassembling the equipment for maintenance purposes was time-consuming because the bolted rods frequently needed to be cut, often requiring the use of torches, as the bolts were stuck on the nuts.

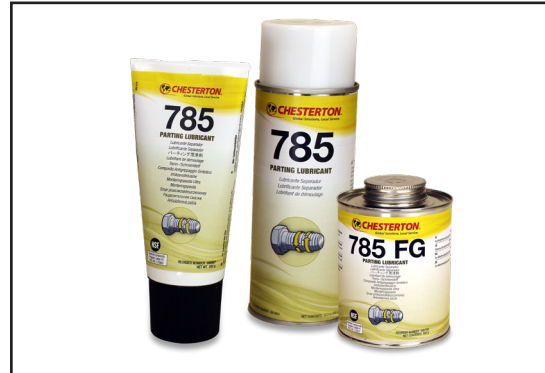
Chesterton 785 Parting Lubricant helps separate metal surfaces to reduce galling and cold welding.

785 Parting Lubricant is a ceramic-based anti-seize that can help separate the metal surfaces of nuts and bolts and stop cold welding and galling.

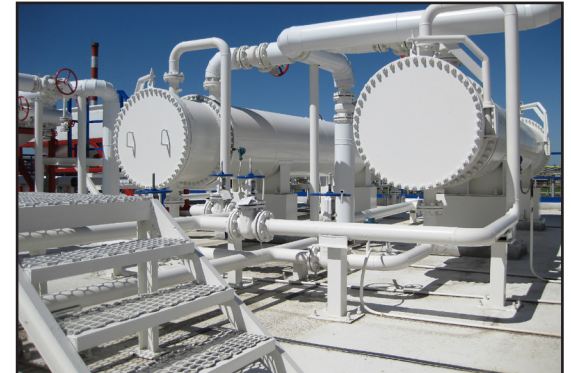
All nut bolts coated with Chesterton 785 Parting Lubricant.

After one year, the results were evident. The 16 bolts coated with **785 Parting Lubricant** came off within a few minutes without any issues. However, the bolts coated with the competitors' products needed to be cut off with a torch. The **785 Parting Lubricant** improved safety by eliminating the need for a torch, which reduces accident risks, and by preventing damage to nearby installations. This paste is now their standard for all high-temperature and torque-tightened assemblies at the plant.
