## Challenge

### Background

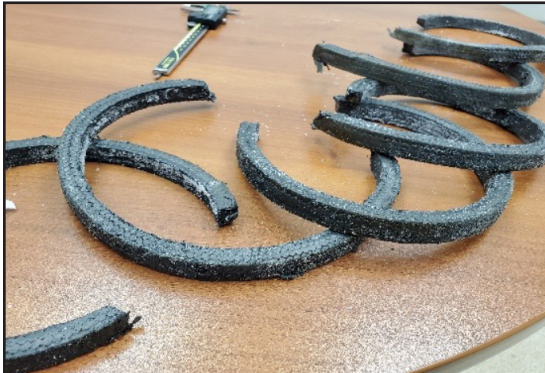
The customer was having trouble with the performance of their mechanical packing in their current pump. The packing seal would hold for only a few hours and required three sump pumps constantly running to keep up with the leaking brine.

*Old rings of failed anti-keystone packing.*

We recommended switching the current 5/8" expanded TFE/graphite packing that the customer was using to **Chesterton 2211 DualPac packing** with a combination of end ring and seal ring configuration to lessen extrusion.

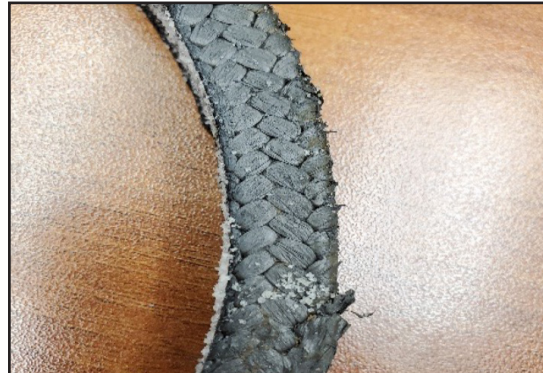
*Damaged packing ring saturated with brine.*

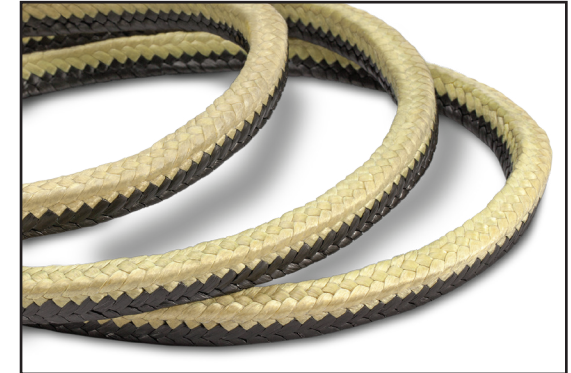
*Chesterton 2211 DualPac packing.*

The **Chesterton 2211 DualPac packing** drastically improved the situation. The packing sealed well for three weeks, producing only a small, steady stream of water. The customer was able to continue operating with only one sump pump running intermittently. The packing was eventually removed only due to a separate, nonrelated issue.
