Challenge

Background

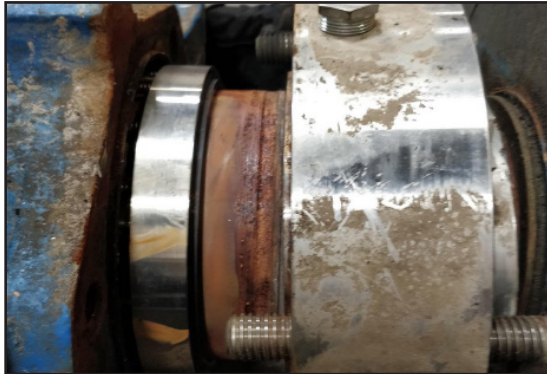
A customer was using a large split case pump with solid mechanical seals. The entire pump needed to be disassembled to change out the seals resulting in weeks of downtime. The mechanical seals had a 6 – 12 month life.

Split case pump with solid mechanical seal.

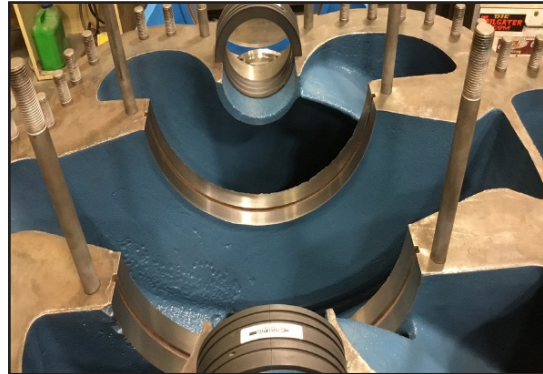
Pump fitted with Chesterton® 442 HP Split Mechanical Seal and a SpiralTrac® Environmental Controller.

The pump was fitted with a **SpiralTrac® Environmental Controller** throat bushings and **Chesterton® 442 HP Split Mechanical Seals** were installed.

Seal change outs are now done in a matter of hours, not weeks. Reliability has improved with up to two years runtime. No seal failures reported since this conversion.

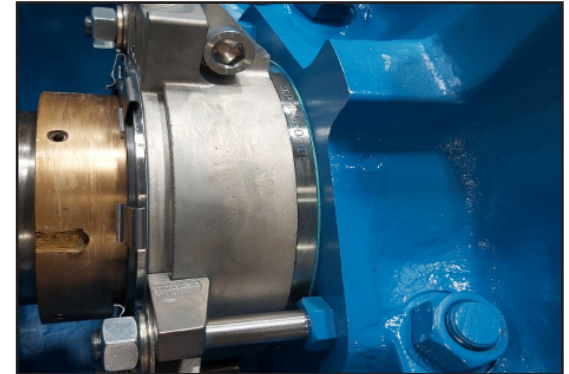
Improved runtime and reliability.
