Challenge

Flue gas desulfurization units are highly corrosive and hard on equipment.

- Extend the life of absorber agitators made with expensive, super duplex alloy to operate in corrosive and abrasive desulfurization environments

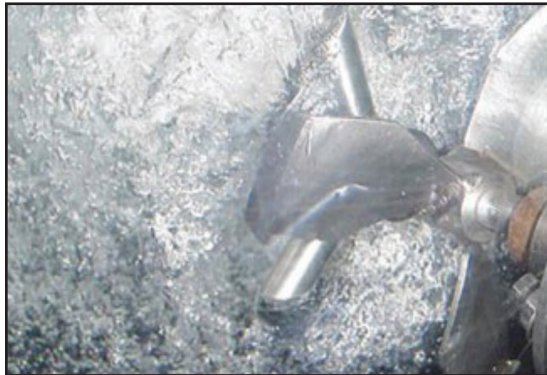
Photo showing the mixer during operation

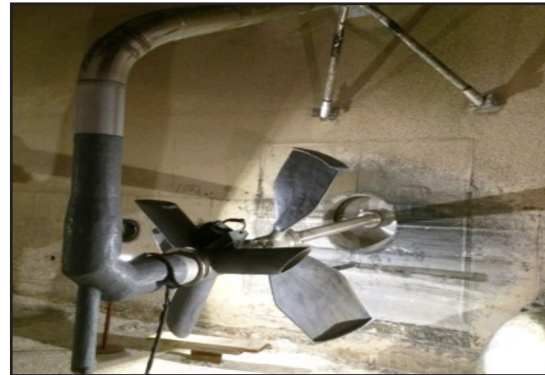
Mixer and lance with the applied ARC products

Abrasive blast surface to Sa 2.5 with 3 mil (75 µm) profile using aluminum oxide media

1. Apply **ARC 855** as a primer
2. Apply **ARC BX2*** at 3 mm (120 mils)
3. Dynamically balanced impellers and rotating lances using **ARC BX2***

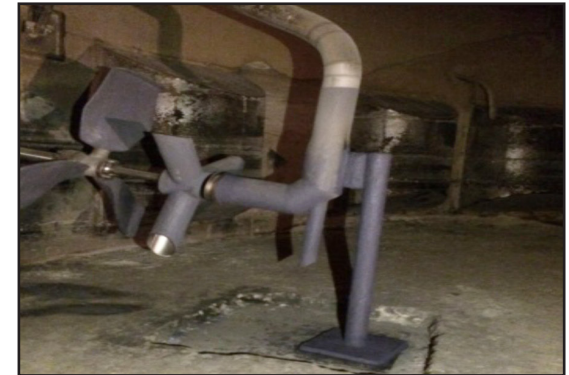
Design was modified to include additional support for the mixer and lance
