New Lubricant Extends Hoist Chain Life by 65% on Assembly Line

Automotive
Products: Chesterton 601
Case Study 046 IL/MRO

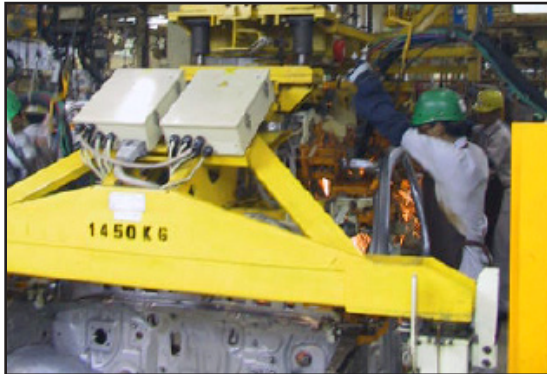
The chains were lubricated with grease and due to its high viscosity it could not penetrate and lubricate the pins and bushings. The chain broke after only 10 months in operation.

Heavy loads impact equipment reliability.

During replacement, the chain was lubricated with **Chesterton 601 Chain Drive Pin and Bushing Lubricant**.

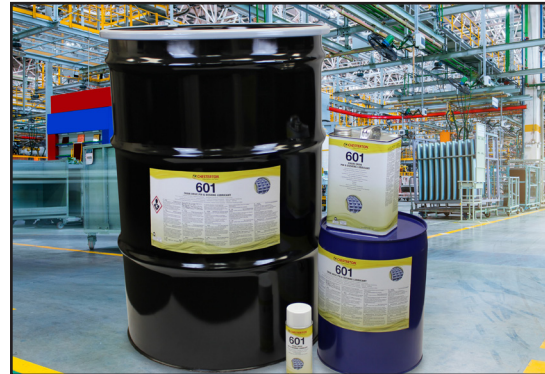
Chesterton 601 provides critical lubrication.

The oil is formulated to penetrate and lubricate the close tolerances of drive pins and bushings to increase chain life and improve operation.

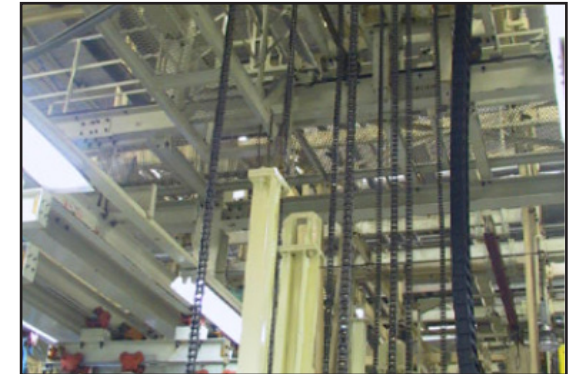
- With the use of **601 Chain Pin and Bushing Lubricant**, the customer observed a 65% improvement in the life of the chain. This equates to a cost saving of \$127 per month for the chain alone, and a cost avoidance of \$17,900 (replacement typically needed every 10 months).
- The customer also observed a reduction in energy consumption as a result of the lubricant.

The solution greatly improved chain life.
