Challenge

Background

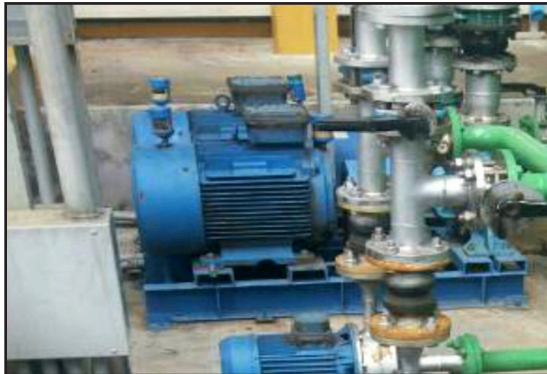
Over greasing led to frequent bearing failure.

The staff at this plant attempted to control bearing contamination of equipment in wet and dusty parts of the facility by frequent greasing, but this turned out ineffective.

The practice led to over greasing of bearings, leading to frequent bearing and motor failure. In addition, some areas were in hard-to-reach locations.

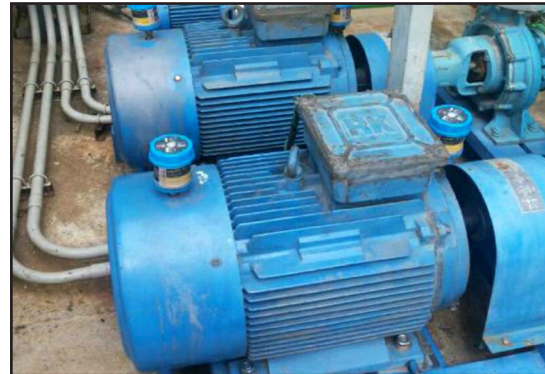
A combination of high-performance grease applied in a controlled manner via the Chesterton Lubri-Cup.

Installed a **Chesterton Lubri-Cup™ VG Mini** Automatic Lubricant Dispenser to apply **Chesterton 630 SXCF**, a synthetic, high-load, corrosion-resistant grease on each electric motor bearing.

Based on bearing size and speed, the **Lubri-Cup™ VG Mini** was set for six months. It applies the correct amount of grease at the necessary intervals.

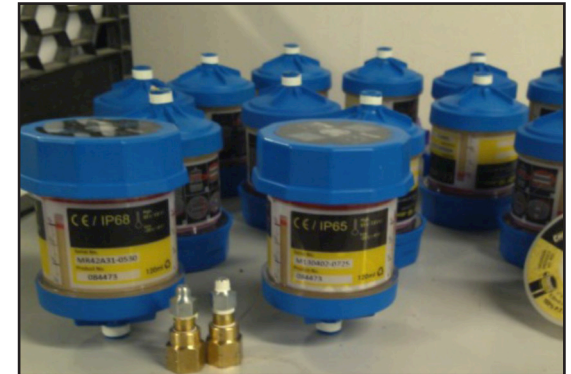
This combined solution resulted in a 75% reduction in electric motor failures on ash, coal, and scrubber areas.

The plant experience a 75% reduction in motor failures.
